# HR 37 "Mia Maria" in her preferred element

Delivered on  
13th May 2008

# Delaminated hull!?

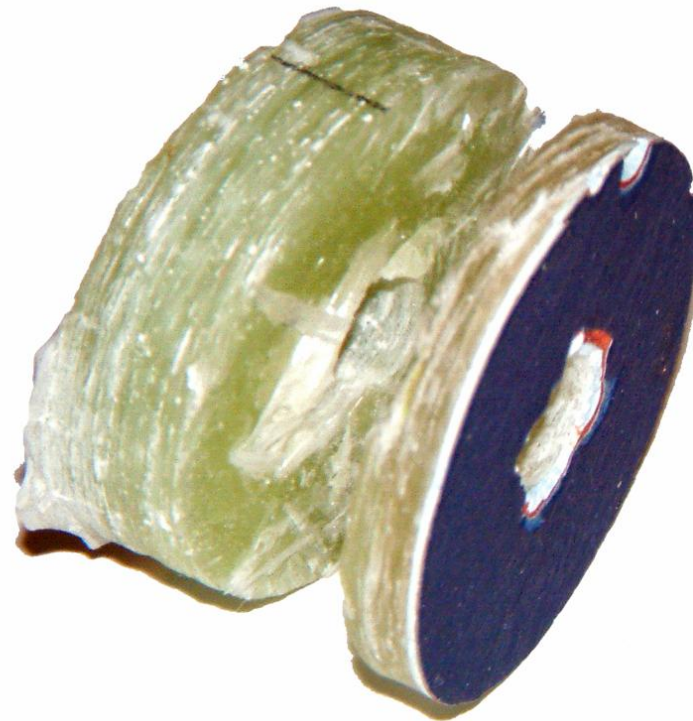
It started with a flushing pump to be mounted. For that reason the hull was drilled through. The drill disc come out in two parts.

4 mm and 8 mm

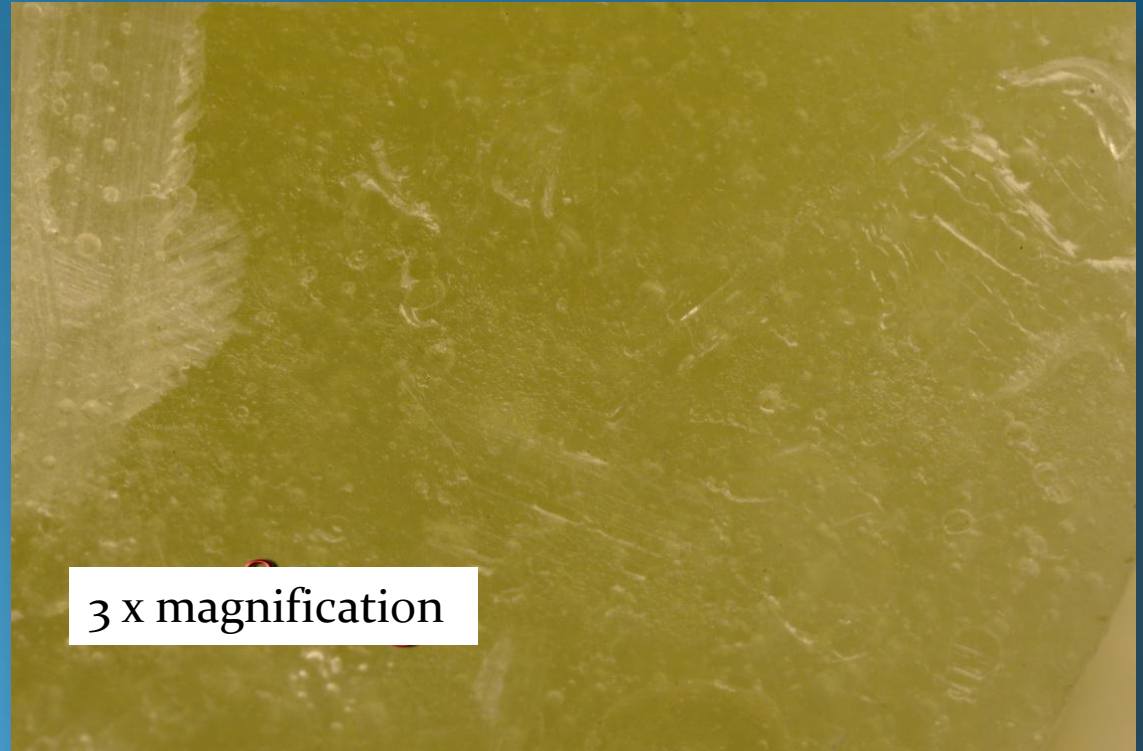
# The outer part of the inner surface of the drill disc

As you can see this part has no binding fibers but exhibits a smooth oily surface.

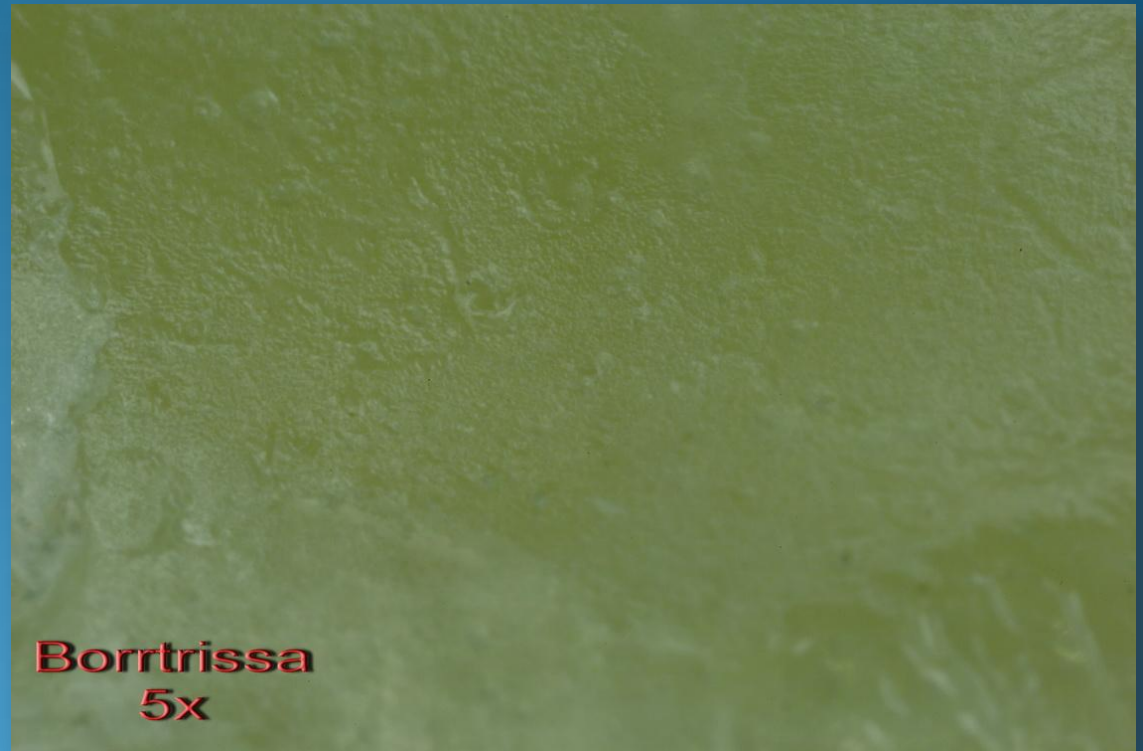
# The inner part of the disc's inner surface

The inside part of the drill disc.

The surface shows, similar to the last image, that there is no mechanical connection between surfaces only a waxy surface.

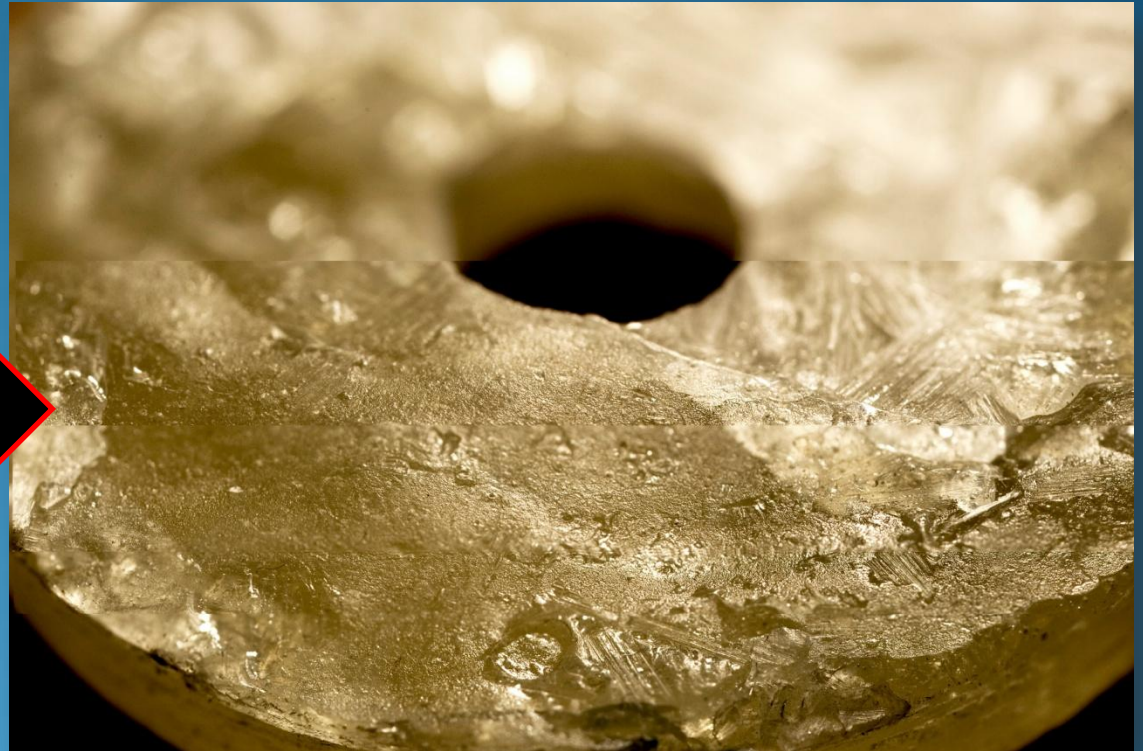
# Sector Photographed drill disc for better sharpness of depth

The two surfaces have been formed to each other but are mechanically separated.

Pictures and investigation shows that this is a manufacturing defect and has not occurred during the the time the boat was being used.

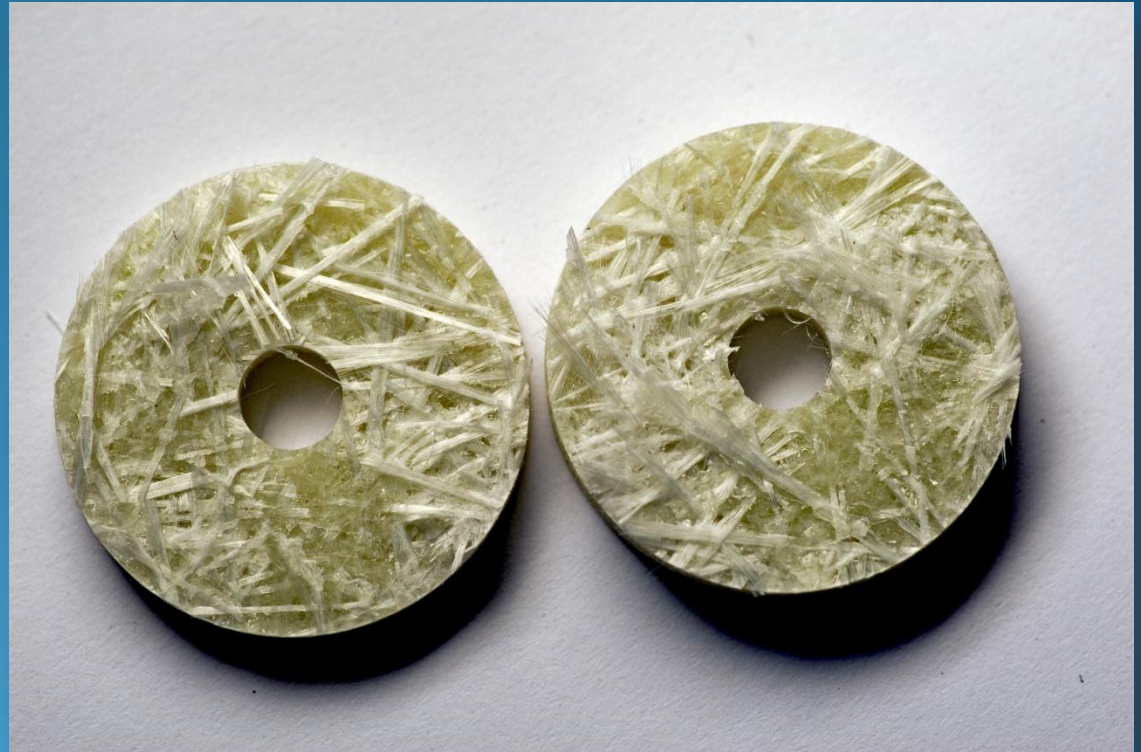
# Drill disc taken from the comparison plate disc

The fracture surfaces of the disc show many fragmented fibers, with same look appearance on both surfaces - Even if the chisel cut some fibers.

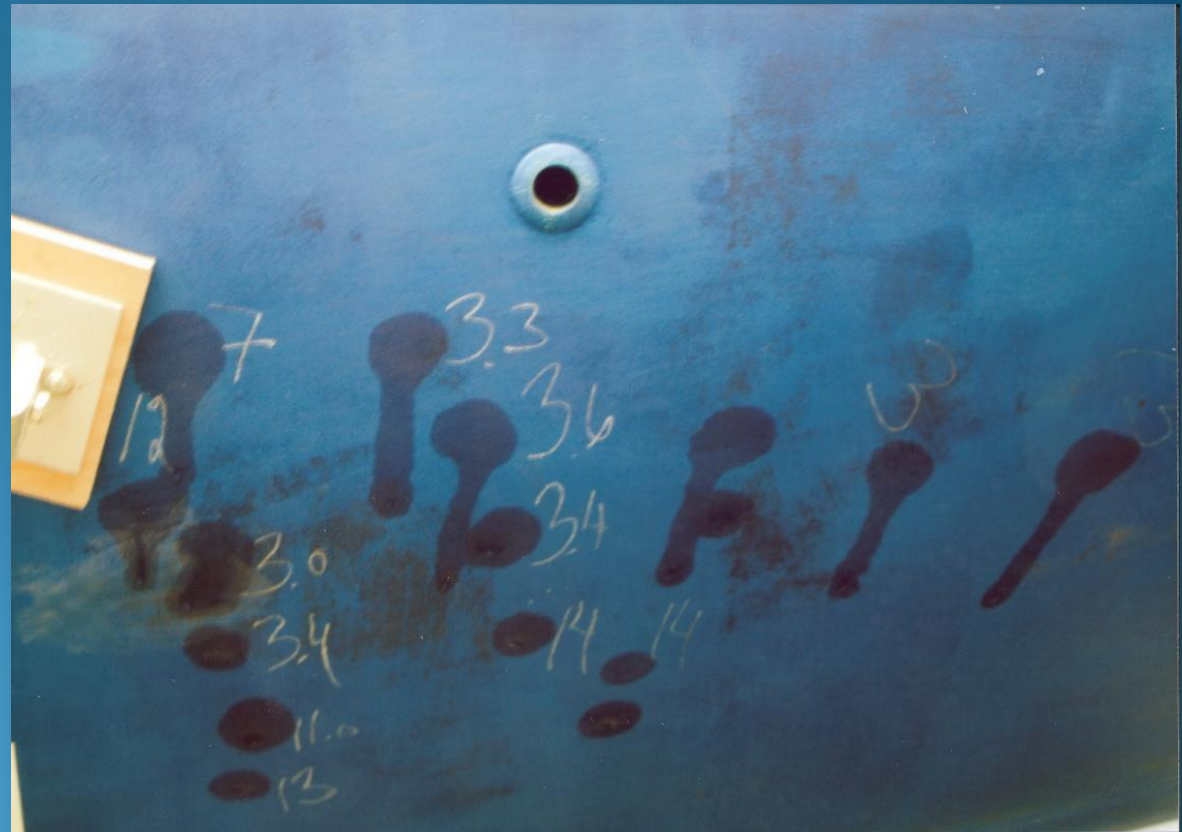
# Delamination measured with ultrasound of Ångpanneföreningen 10/08/2009

Measuring point, the round Dark Spot, with specified depth from the hull surface area to the delamination.

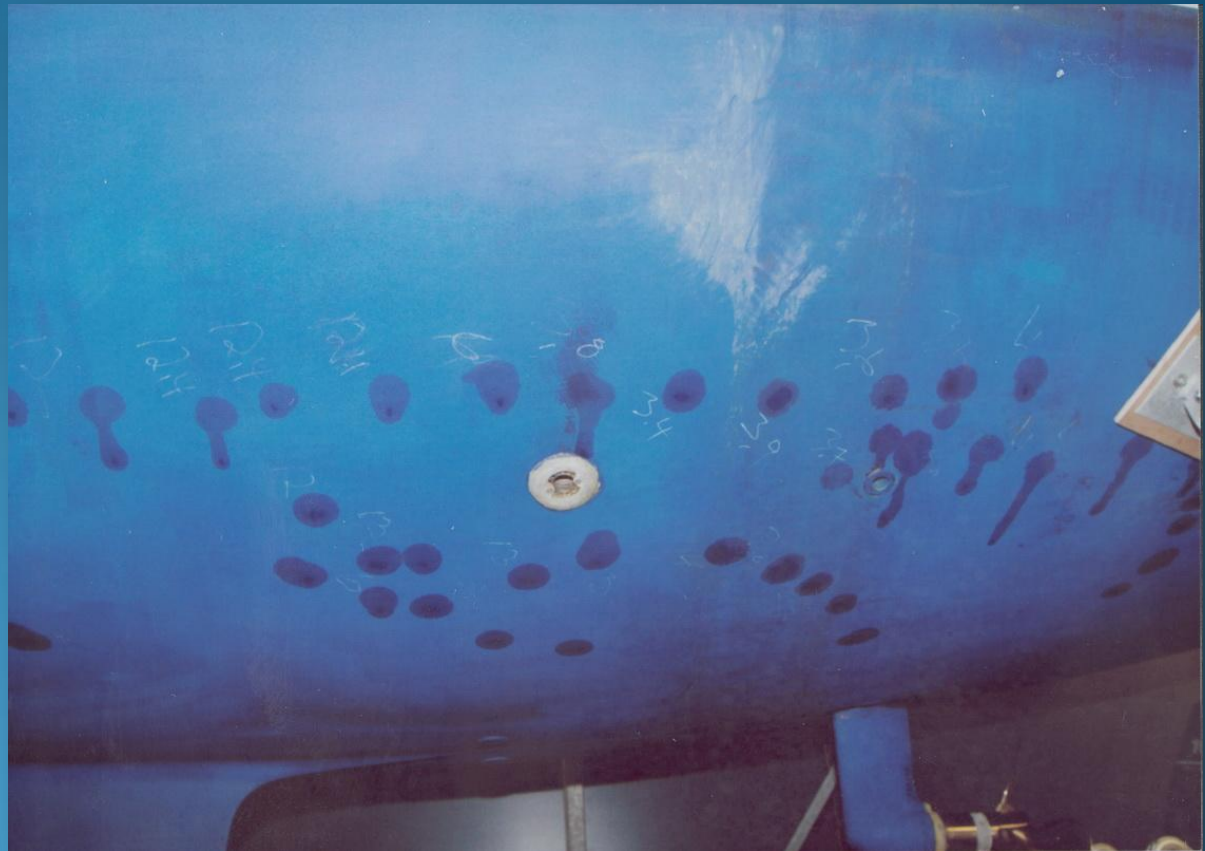
Ångpanneföreningen tried first find the boundary of the delamination. But when that was not found, they switched to measuring the entire hull a random sampling rate. This in a line about midway between the keel and water line – see image.

*"The defects apply in large parts of the hull"*

*"The defect in the lamiate can hardly be considered reparable and why seaworthiness of the boats is questioned"*

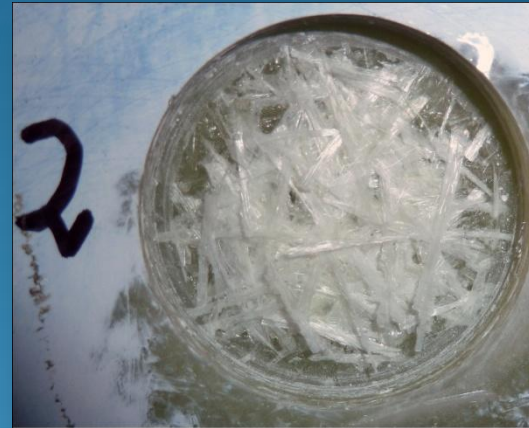
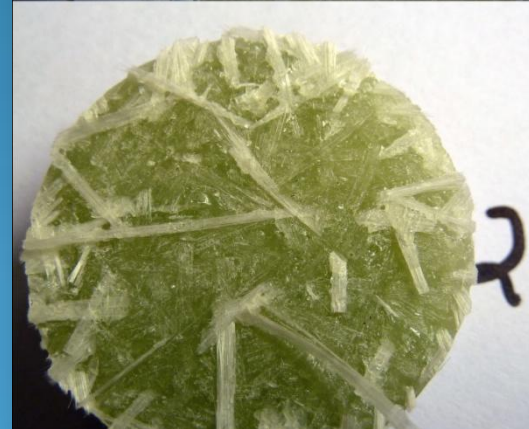
- Hull: 0-14% of minimum ultimate tension.
- Fracture surface There are very few fibers and polyester without fracture surface.
- Bending stress: Increases by 80% compared to a homogeneous hull
- Hull Strength: Reduced to almost 50% of normal value
- Grounding: Can mean consistent cracks in the hull with water flooding as a result
- Teature: The boat is classified as unseaworthy

Note the difference in the fracture surface.  
Prof. K-E Olsson: in a "healthy" laminate the fracture surfaces have similar appearances

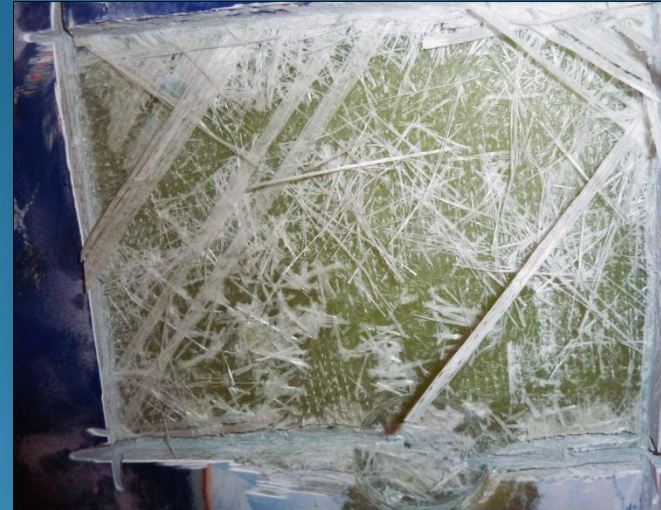
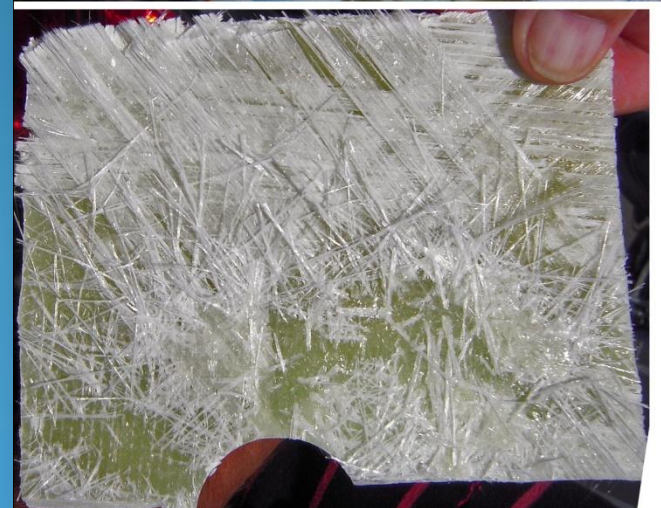
Note that in the removed plate about 6 mm deep are multiple layers of fiberglass mat without matrix. In test records of Ångpanneföreningen is shown that many erroneous values are at that depth. DVS errors are found in two different layers in the hull which we were unaware of before

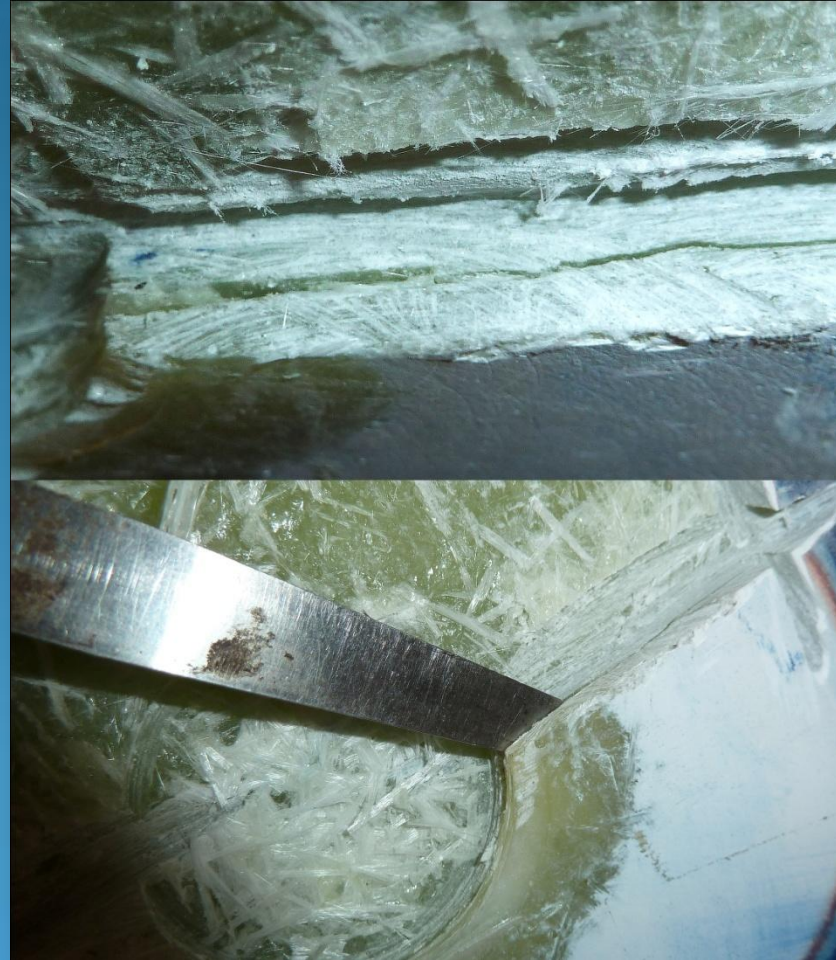
### CRACK INSIDE IN HULL

The hull was discovered a crack on about 3,5-4 mm deep when Production engineer Krister Sjoberg easily had broken up the test plate.

This crack could feeler gauge be pressed in about 18 mm.

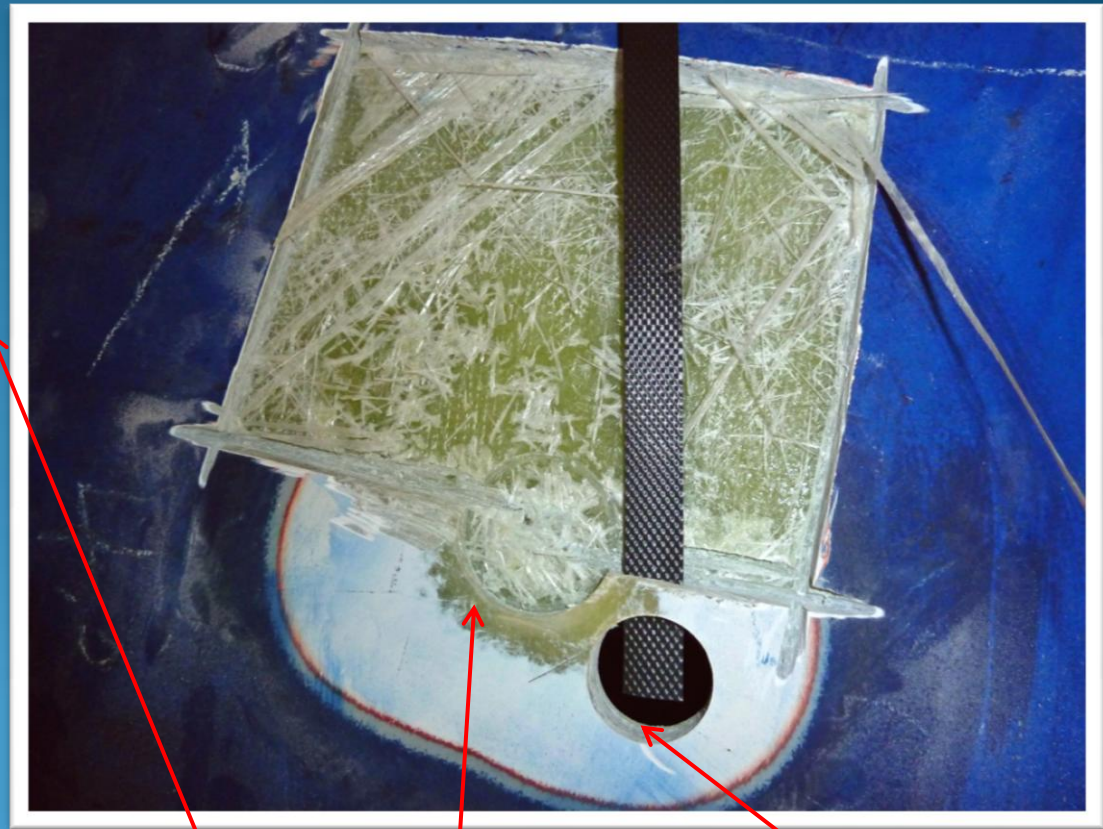
Here has a luggage strap been stuck into the laminate at the lower edge of the plate HR themselves have cut out from the hull.

**The strength should have been 100 kg/cm<sup>2</sup>- meaning 10 times higher than the readings obtained**

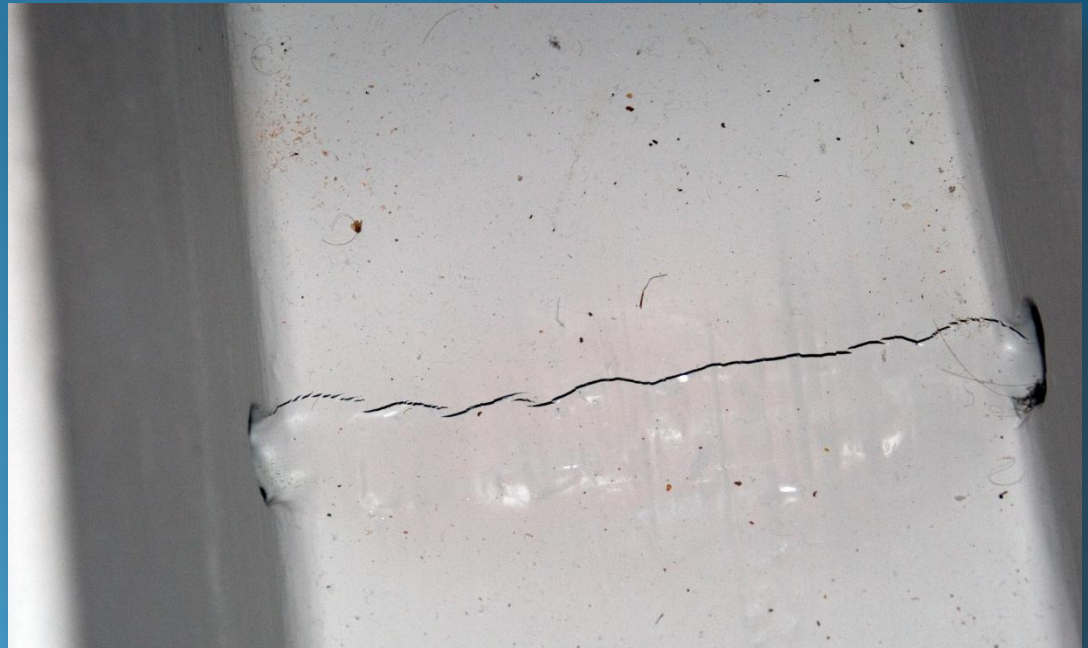
# Crack in the box section

Crack occurred thereafter.

**William Bekking / Erling Kroon.** "This is not how things should look like!"

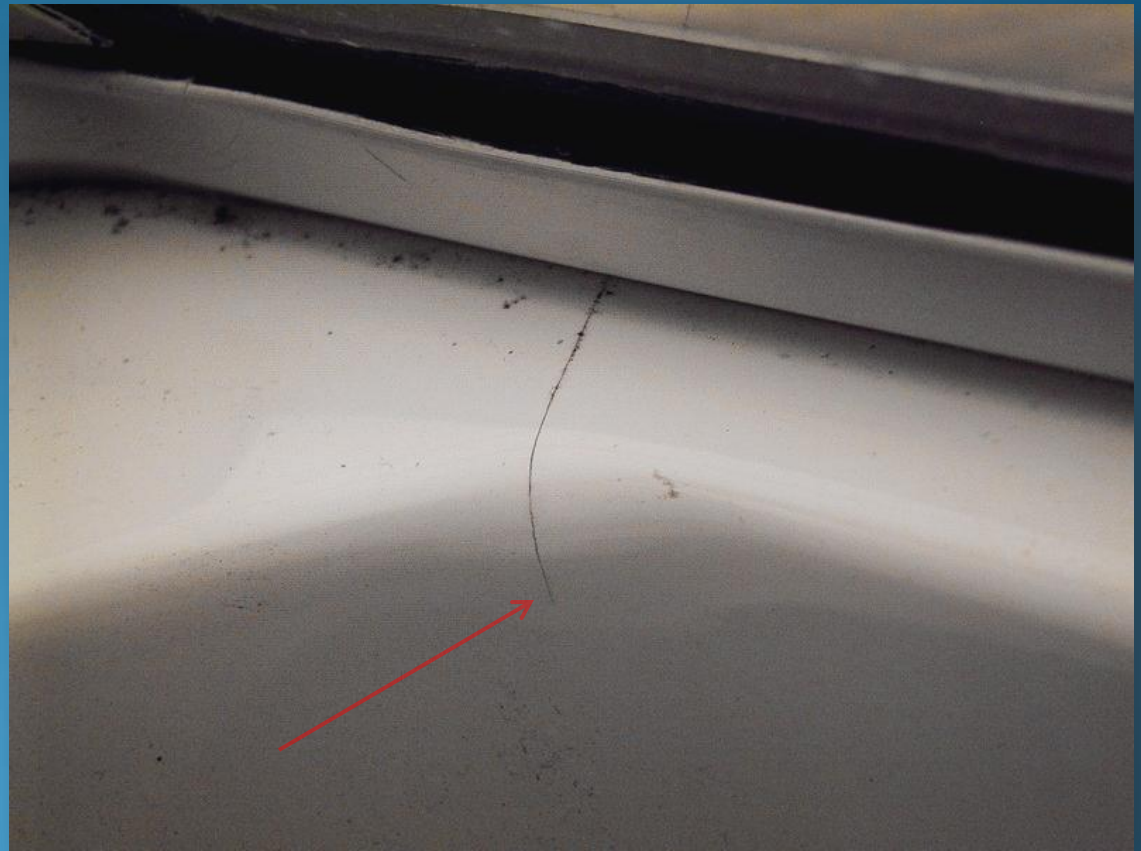
# Crack in the superstructure near the windshield

This picture taken  
20,091,022th  
Note the length of the crack.

According to civil engineer Bengt Sätterman this fracture is due to weakened hull. The boat has been remarked "soft" mid-ship several times to HR.

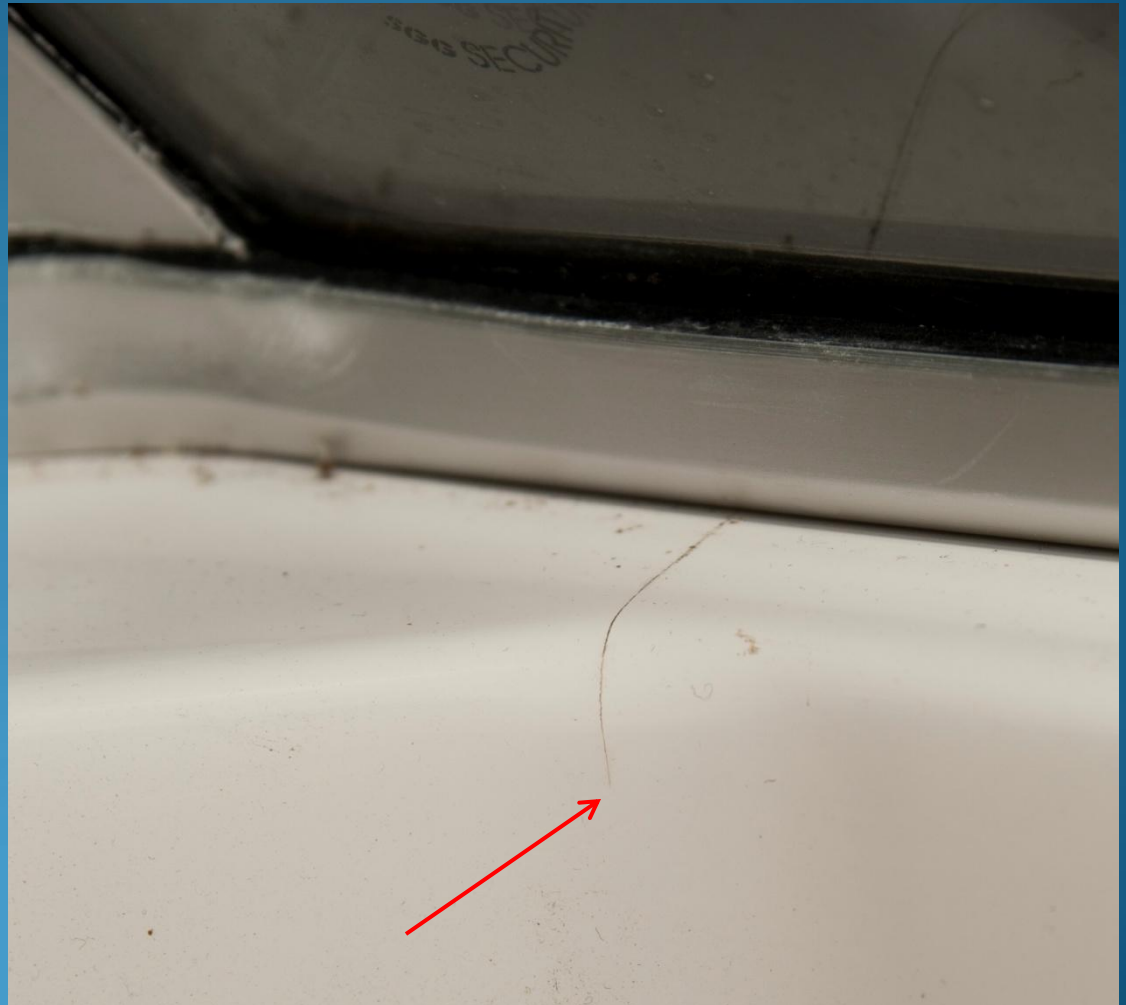
# Crack in the superstructure near to the windshield

This picture taken 02/24/2010  
Note the crack length now.

Civil engineer Bengt Sätterman:  
"Fatigue of the material causes the crack to expand."

Bengt Sätterman goes on to say:  
"Most likely there are already more cracks or more are about to appear."

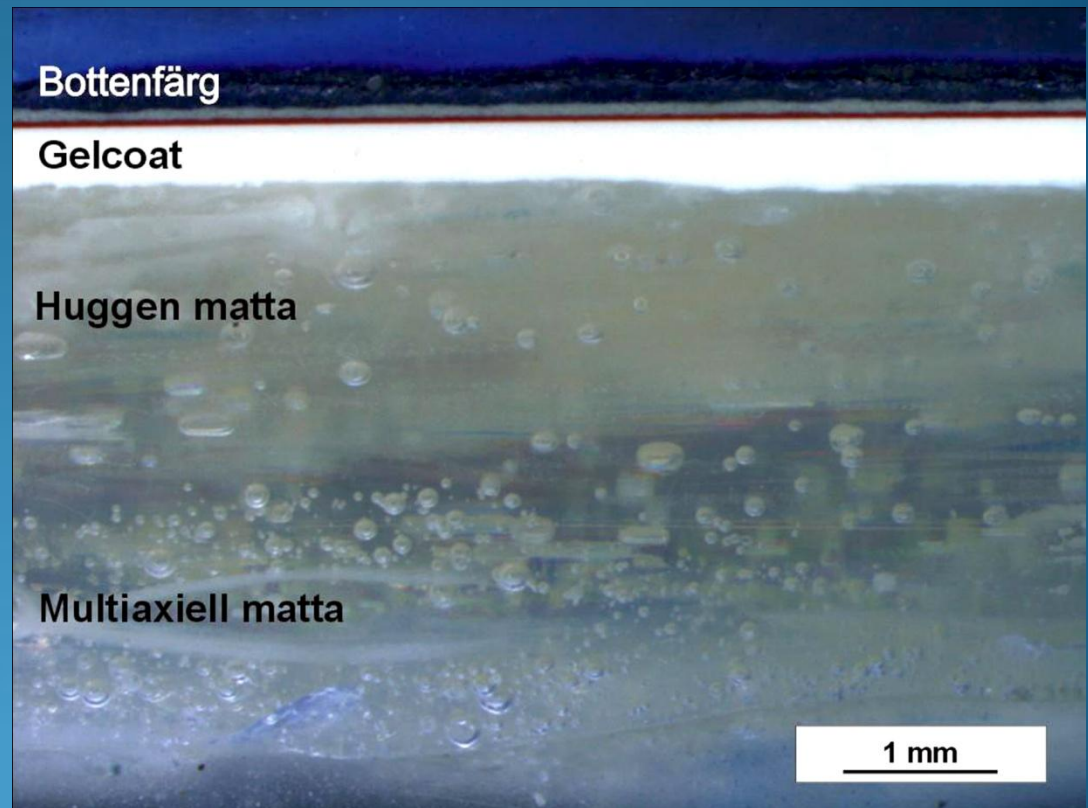
**Note the porosity in this and  
subsequent images**

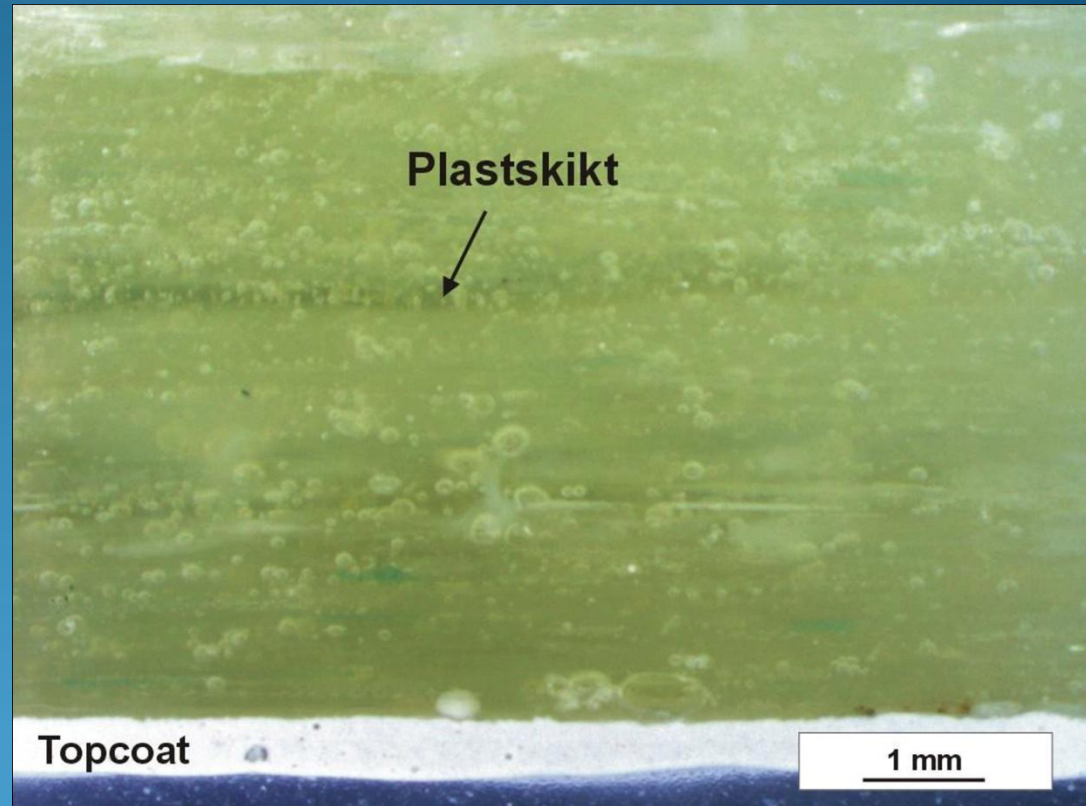
Ad Manus Materialteknik AB found 2 plastic layers in the hull that missing glass.

**Ad Manus Materialteknik AB:**  
Notably, in the figure is a layer consisting of polyesterplastic only  
The reason for this layer is likely hat too much plastic has been used in the lamination.

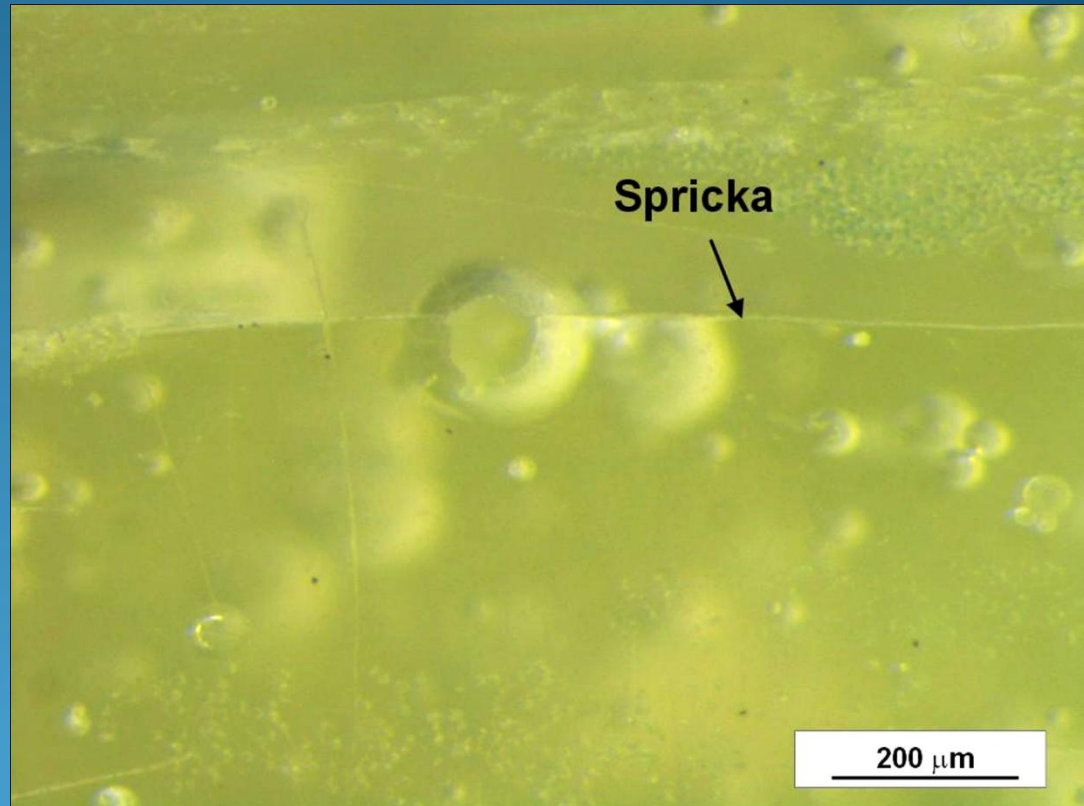
**The study further found a crack in the hull at the depth of 5.7 mm**

Ultrasound examinations showed defects even at about 6 mm in the hull and this study verifies the ultrasound examination. The defect is widespread all over the hull but is hidden from the ultrasound search where defects were indicated at about 4 mm deep.

**Ad Manus Materialteknik AB**  
Cracks in the laminate were also noted in the microscope study. The distance from the outer surface to the cracks was about 5.7 mm.

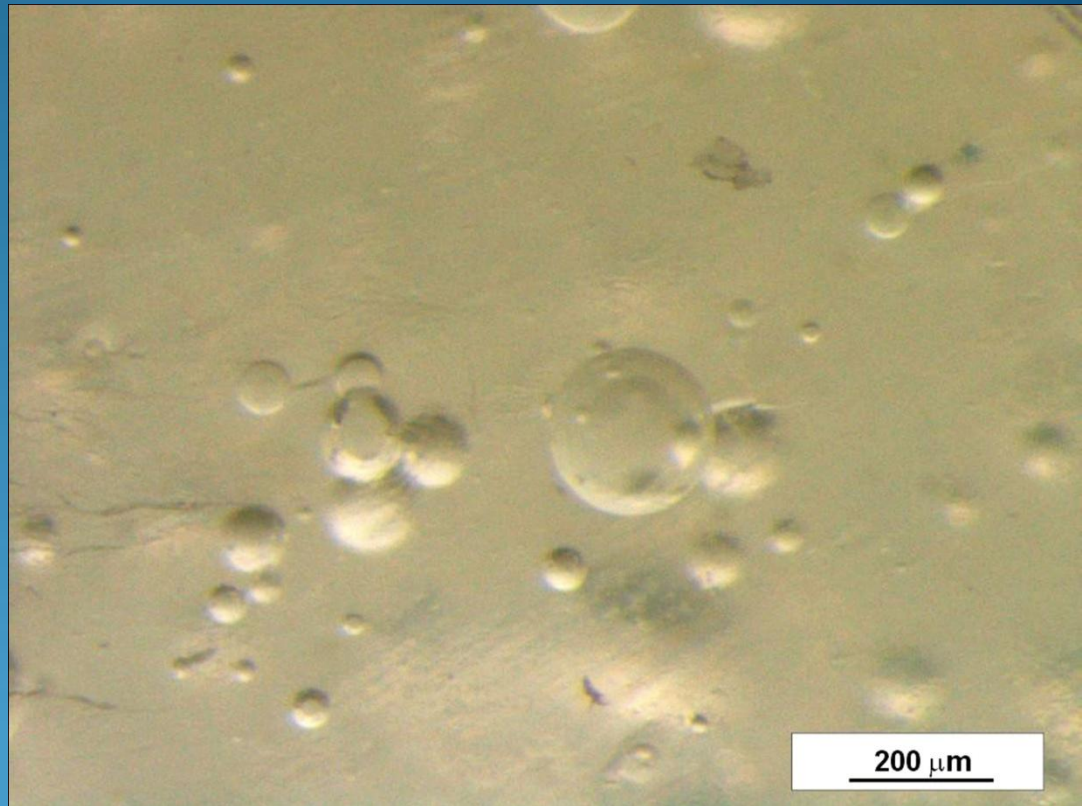
New fracture surface was therefore created by cleaving a part of the inner hull disc. The result can be seen in this picture. The breaking surface is almost completely smooth, which is normal.

The rough surface of the previous image thus indicates that the bond between the two parts of the hull disc was poor (nonexistent?)

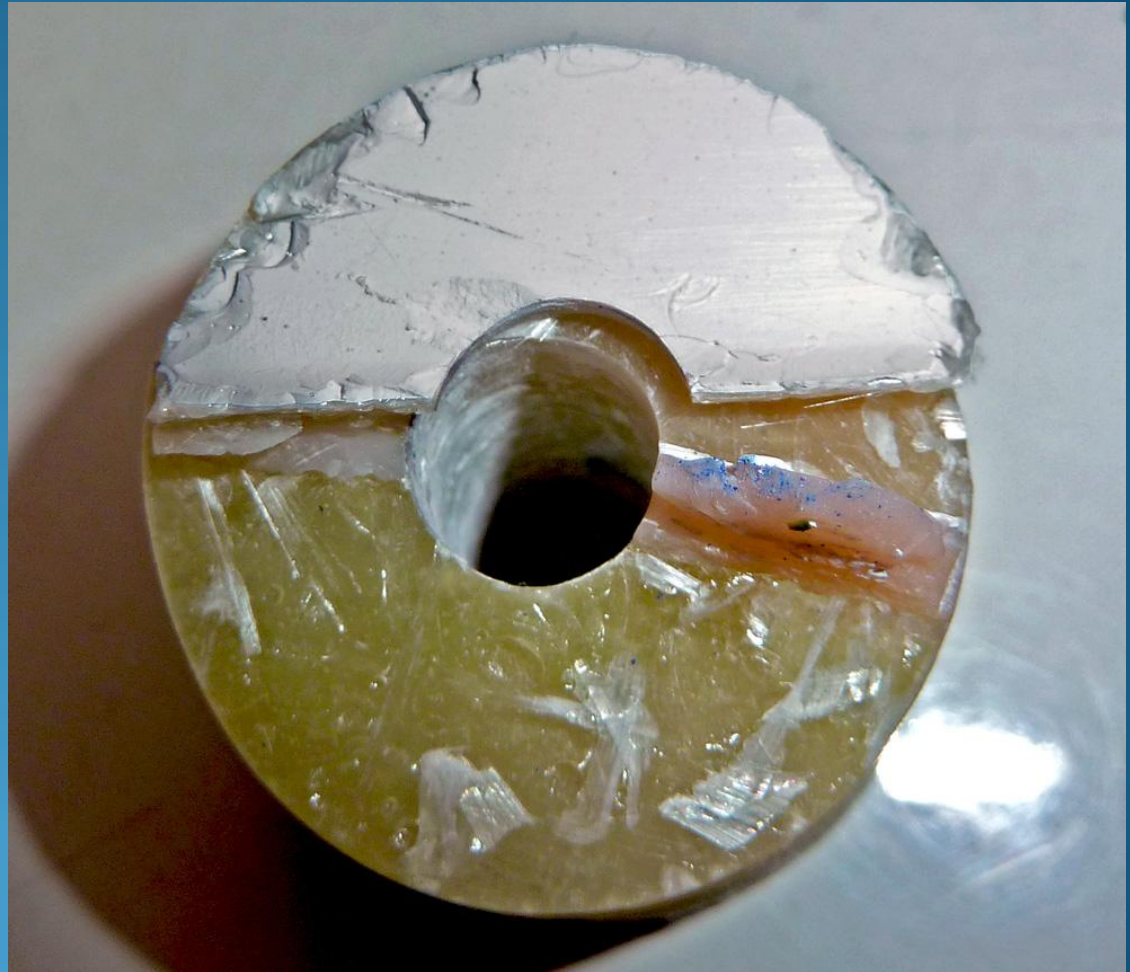
The disc was to be used for determination of por content. During analysis of material, a crack measuring 2 / 3 of the surface was revealed.

**These states the disc wholly  
inadequate in terms of  
adhesion between layers**

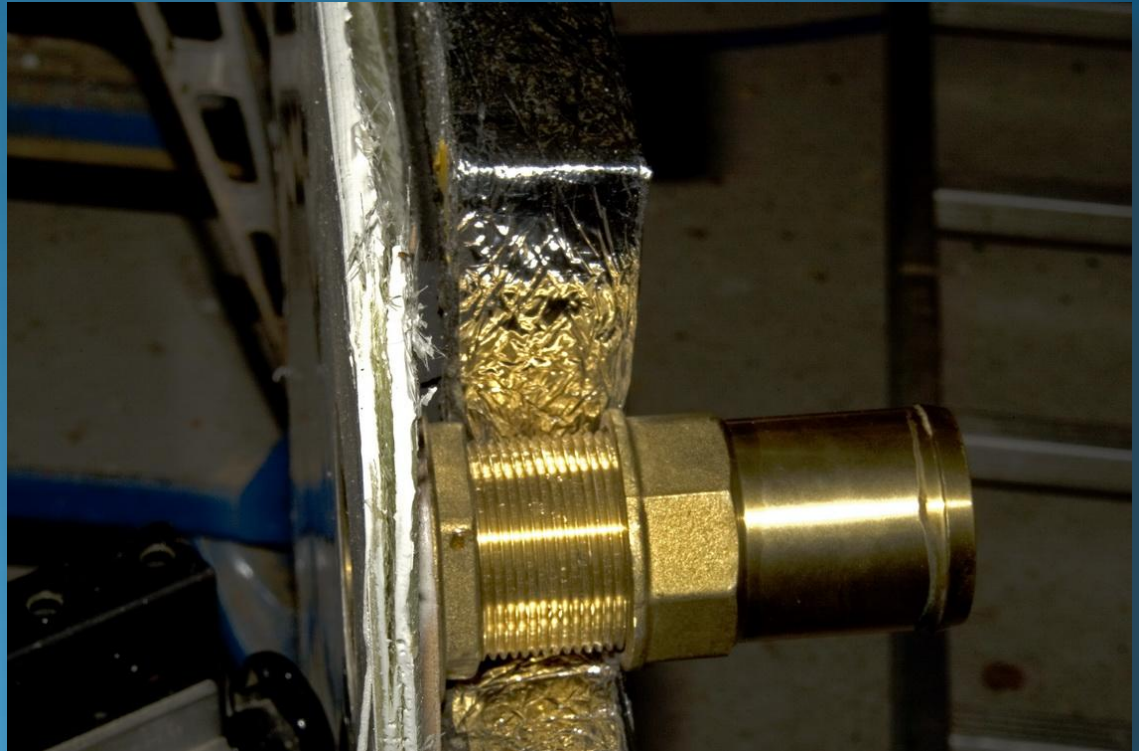
# When changing the engine in late autumn 2008 - 4 months after delivery

The gelcoat on the surface burst into splinters. The sides of the cover was completely broken

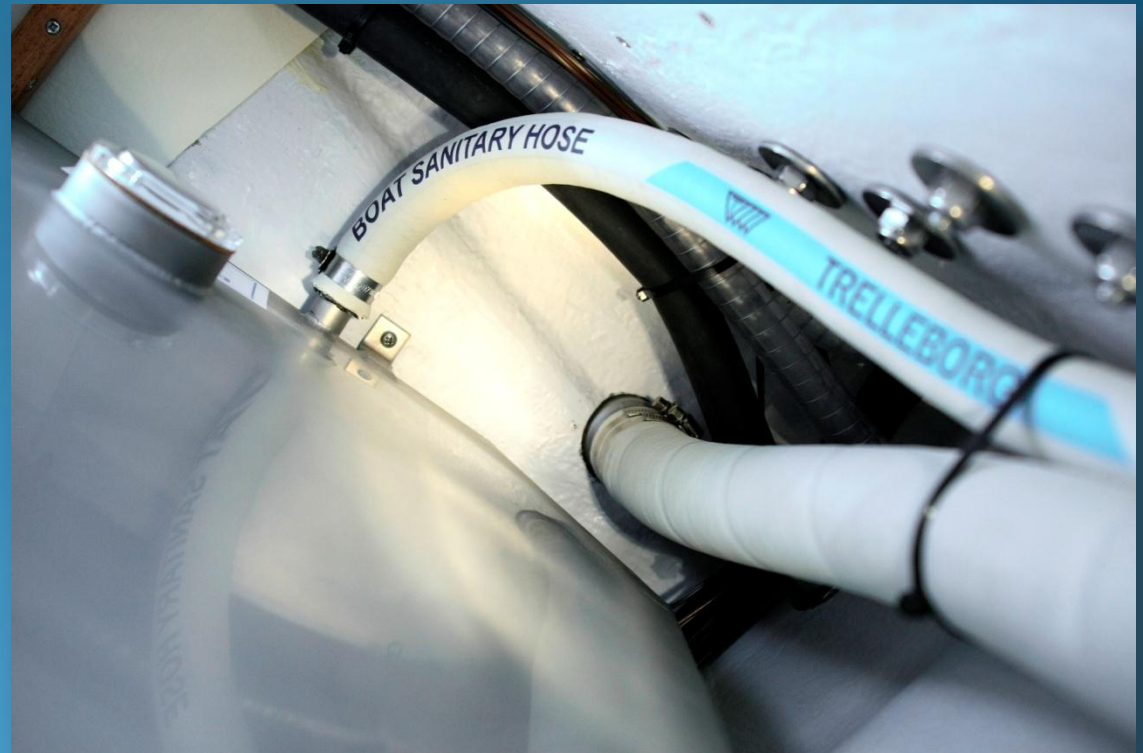
# Toilet tank was loose

**Toilet tank was quite loose at delivery and a thumping sound when sailing indicated this.**

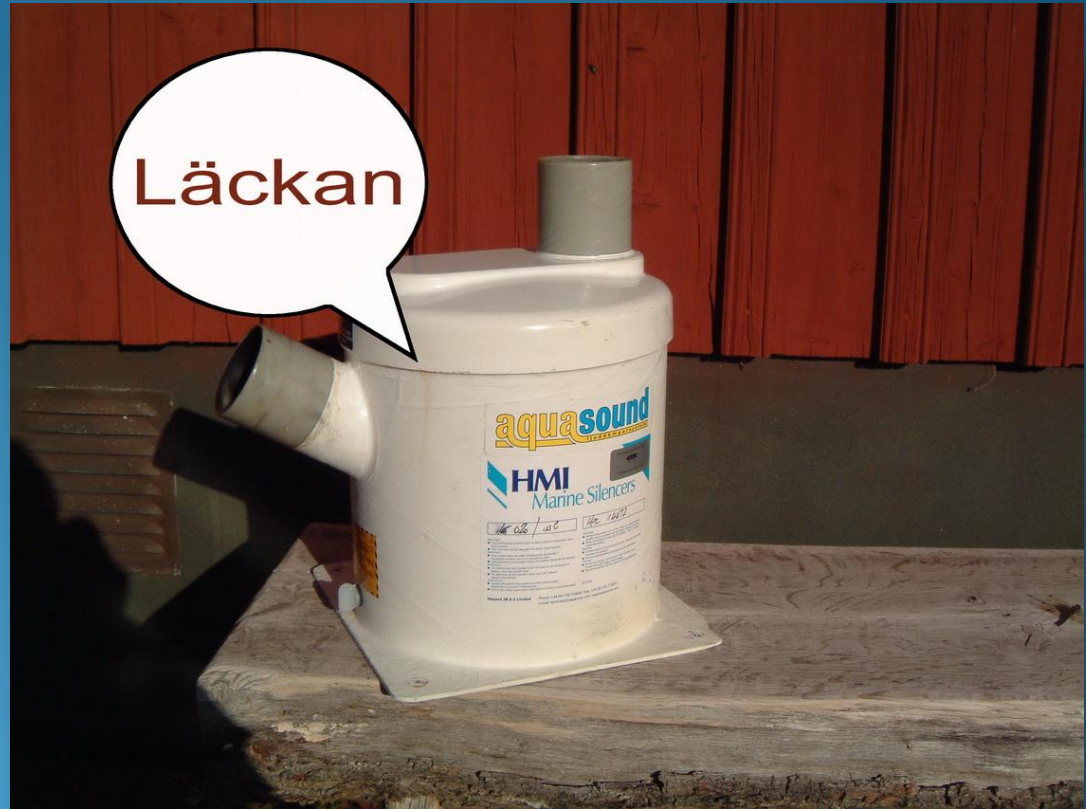
# Leaking muffler

**That the muffler was leaking was discovered in Sept. 2009 th**

I got to replace it myself through the general agent in Sweden. HR rejected the warranty

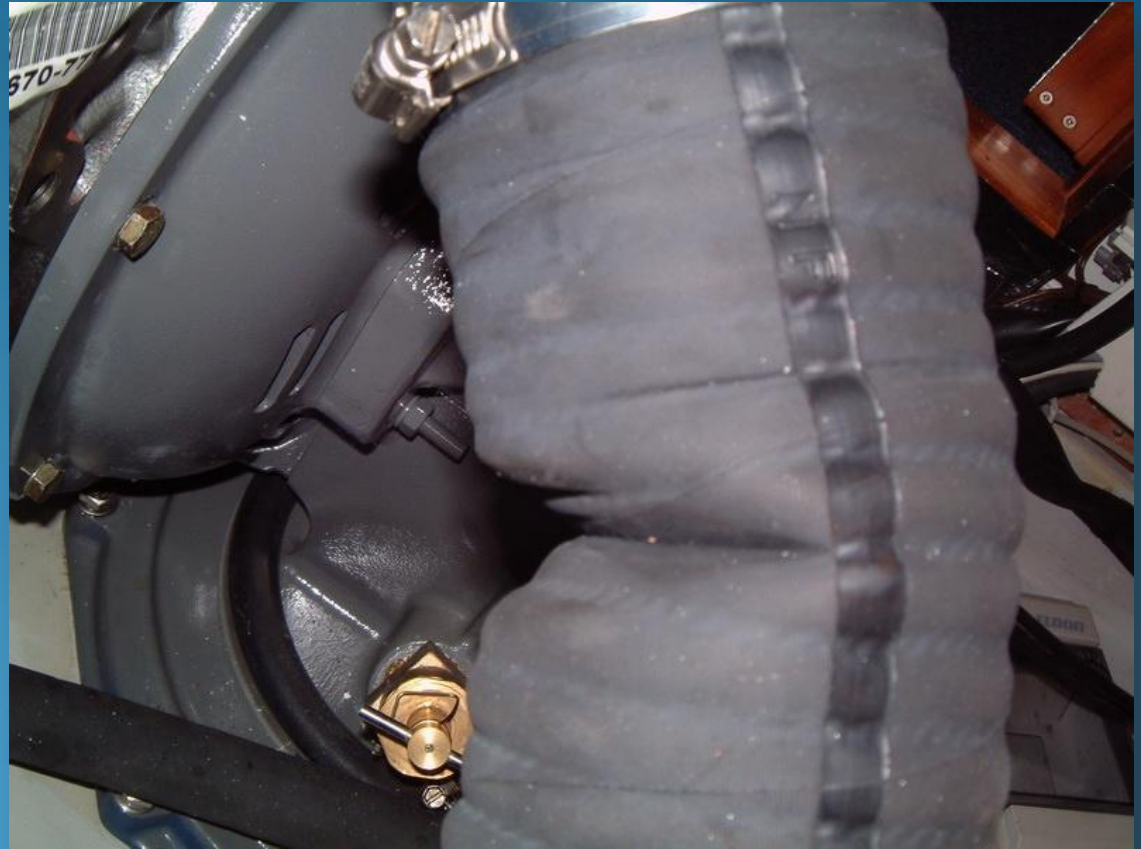
# Muffler tube which collapsed due to tight bending

Muffler tube which collapsed due to tight bending.

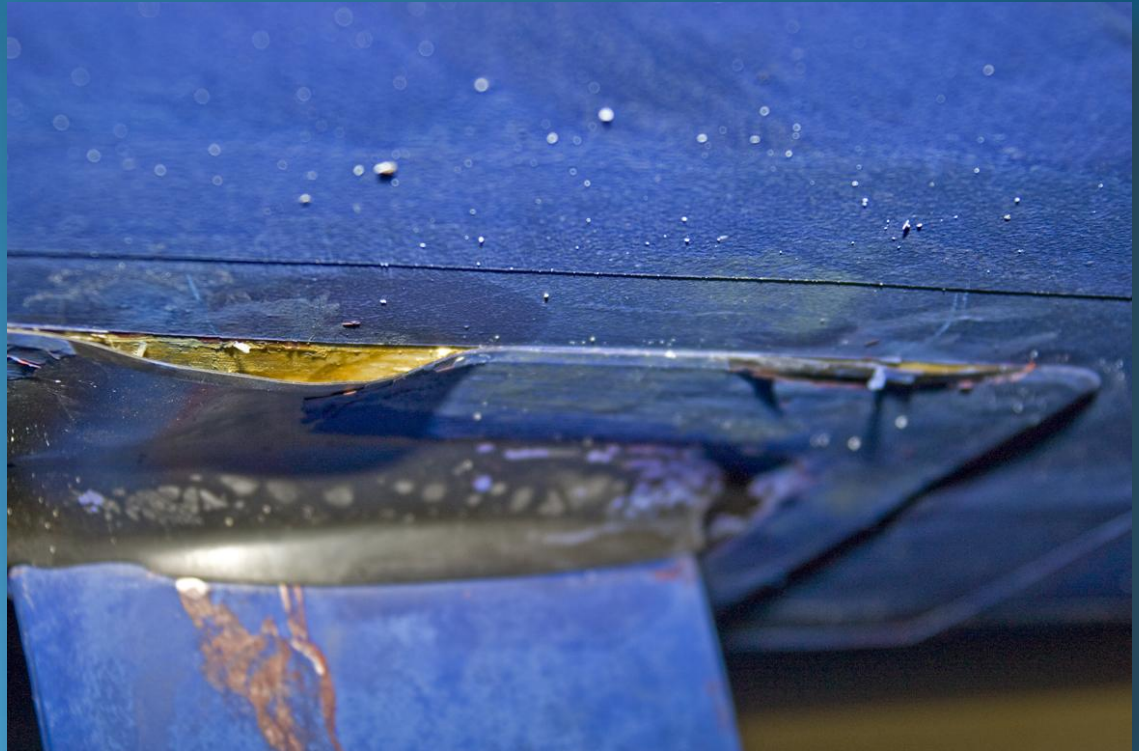
# Loosening rubber gaiter after 4 months

## The whole gaiter was loose
