# HR 37 "Mia Maria" in her preferred element

Delivered on  
13th May 2008

# Delaminated hull!?

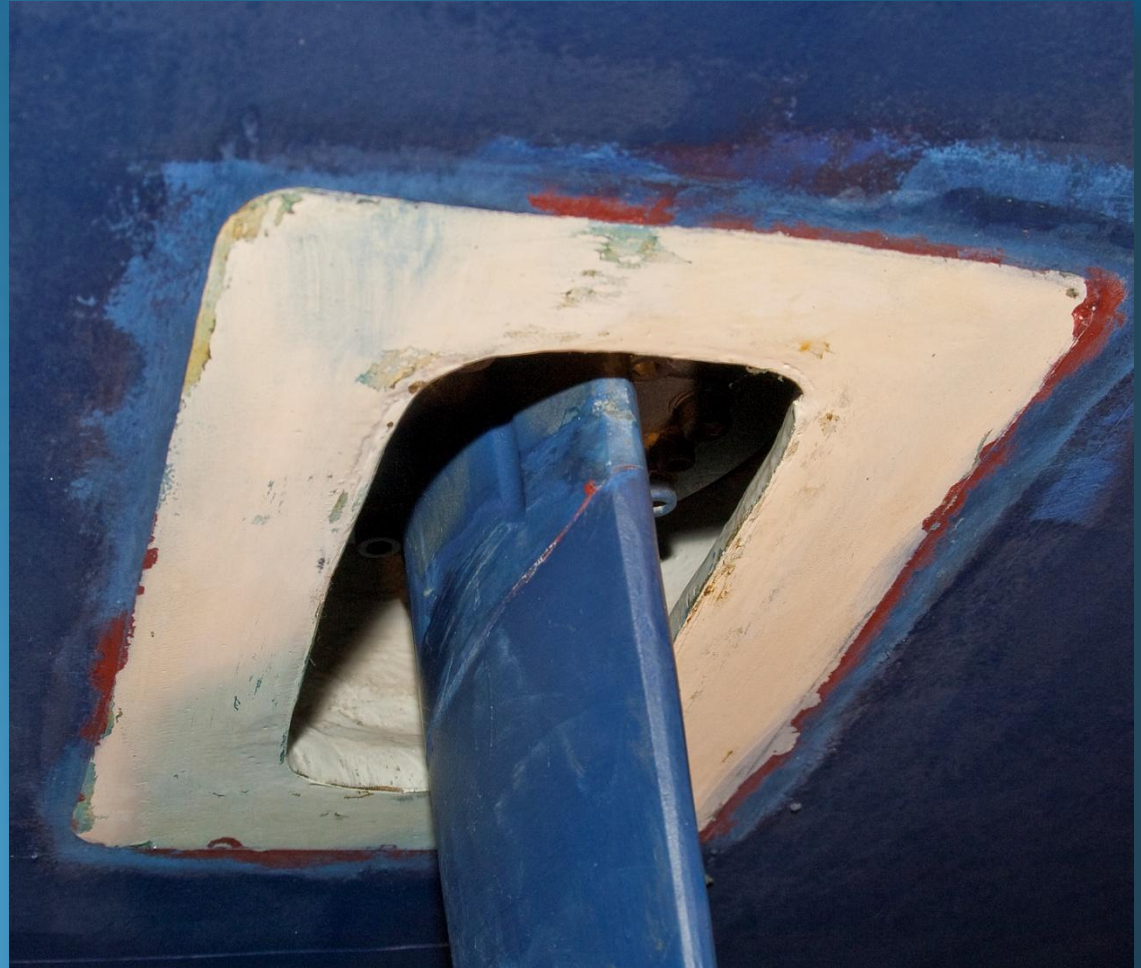
Loosening rubber gaiter after 4 months.  
The technical description says that the hull is treated with 2 layers of epoxy paint - but evidently not so where it is not visible!

Probably the skin fittings are similarly performed which will result in water damages in the hull in a few years time.

All hull penetrations **mushroom heads** must therefore be removed, inspected and repaired.

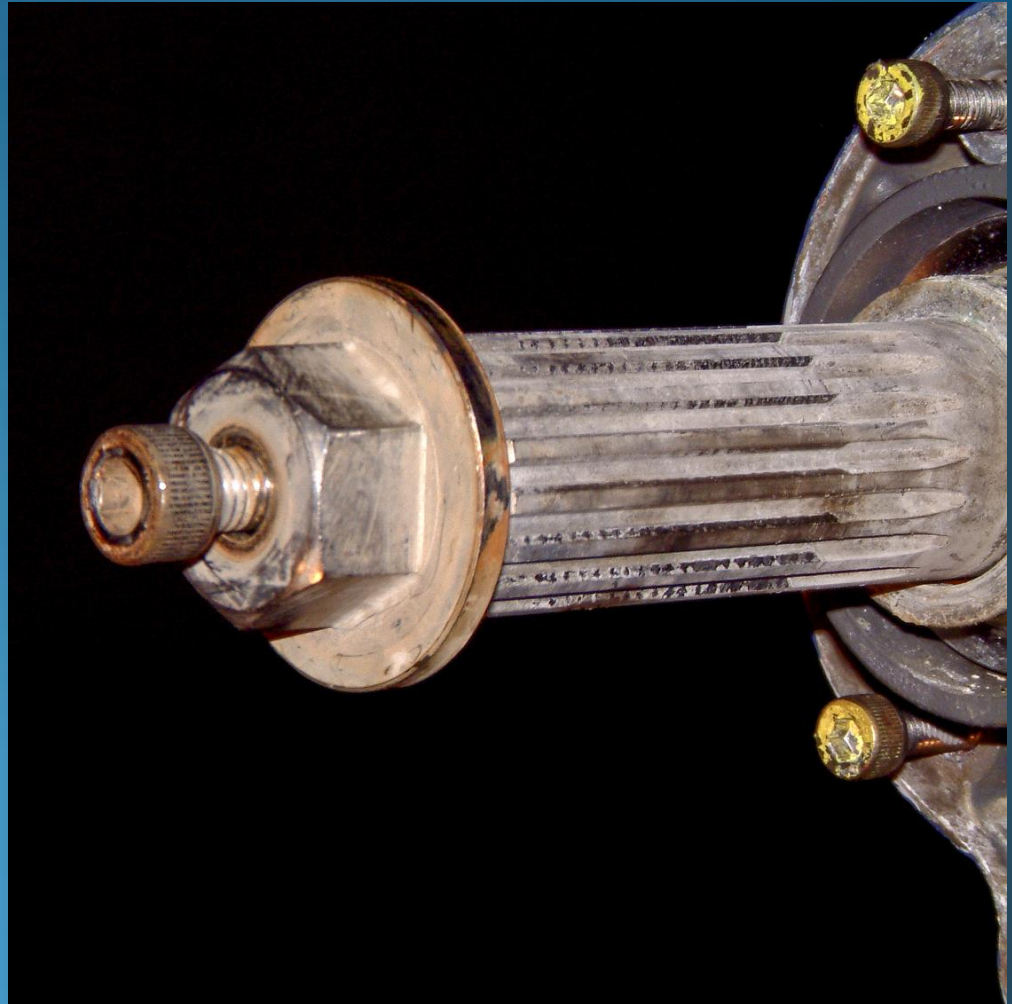
# Loose and improperly mounted propeller by Hallberg-Rassy

Where is the grease on the shaft?

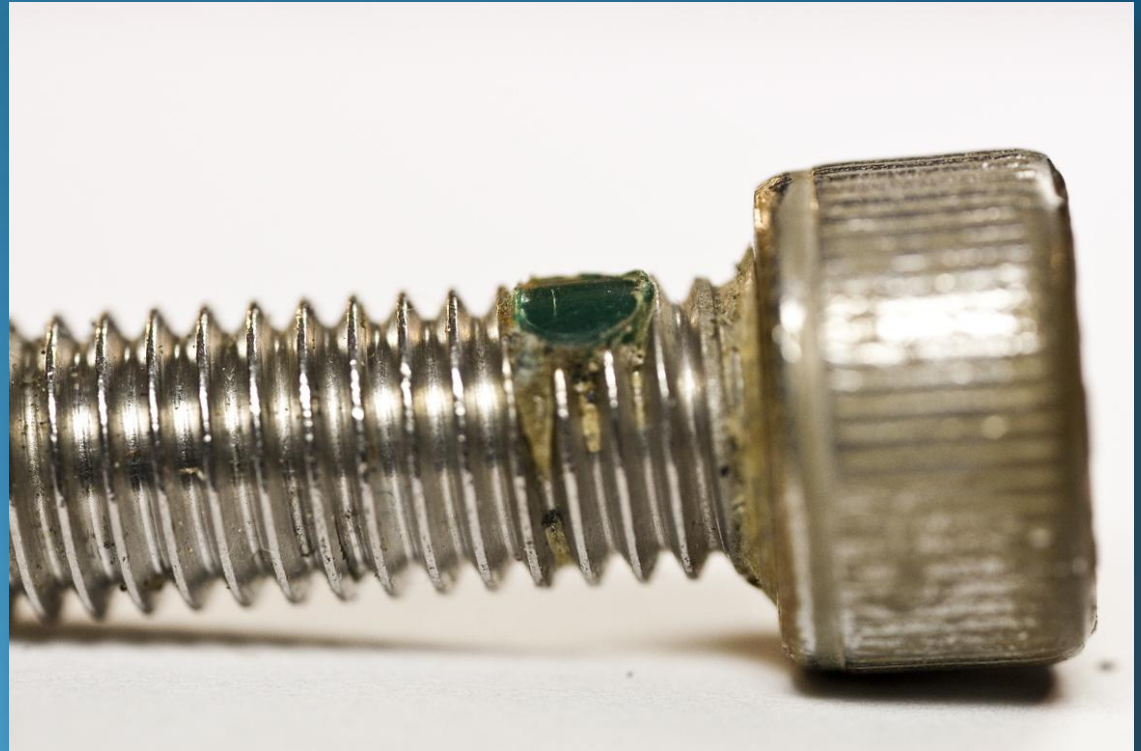
# Loose and improperly mounted propeller by Hallberg-Rassy

If the error had not been detected,  
the propeller would have been lost  
during 2009 season.

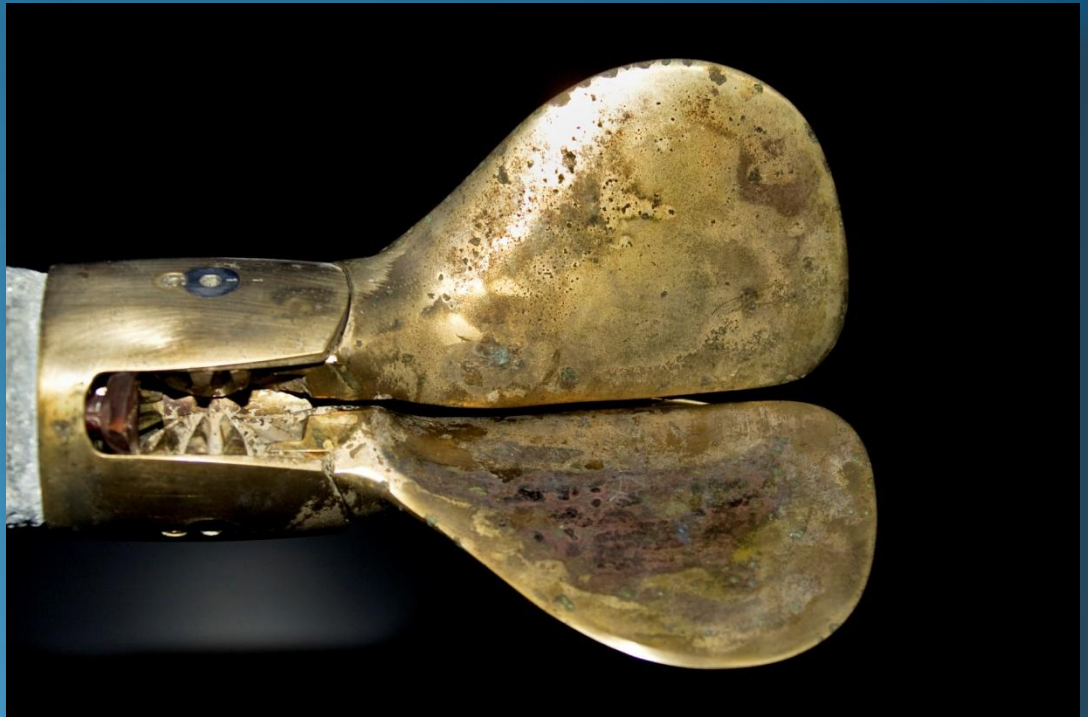
# Corrosions on propeller after four months

Gori Denmark repaired the propeller at our expense..

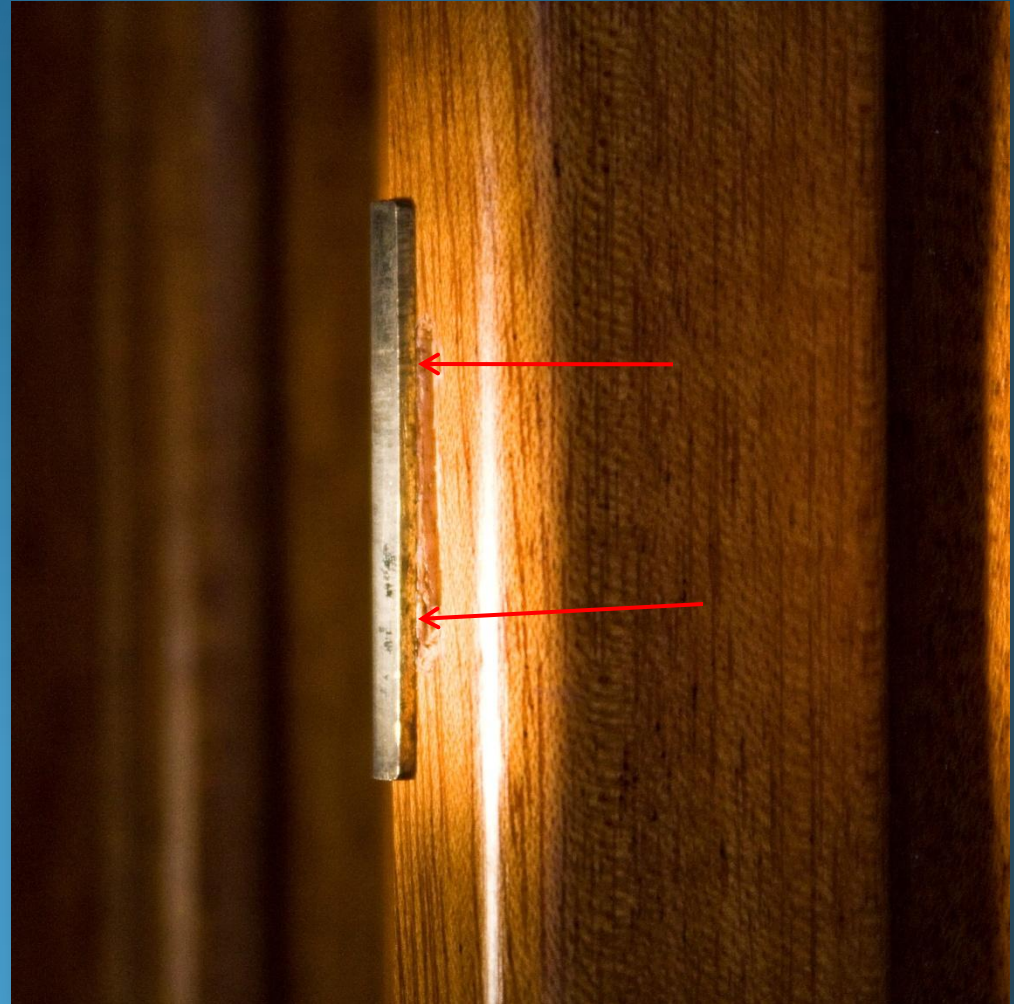
# Skylights skruvade mot däck

After sailing there were water droplets inside the skylight in the toilet. When the screw was removed it was found that no seal was applied to the screws.

**Four screws were broken with the screwdriver.**

The design means there is always a pool of water above the bolt head with corrosion between aluminum and stainless as a result.

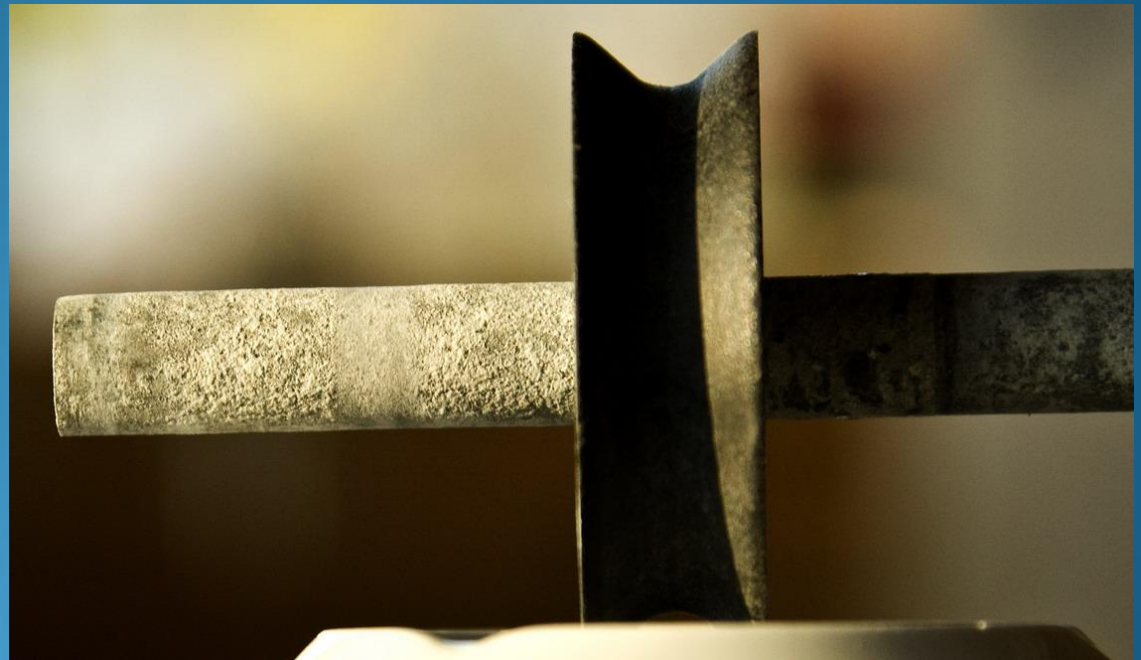
# Corrosion on the shaft

After 4 months was found corrosion on the aluminum shaft .

**New stainless steel shafts were turned in Karlskrona at our own expense and assembly**
