Repairing And Servicing The Yanmar SD 40 & 50 Drive Cone

Provided by Dave Leu of S/V Leu Cat

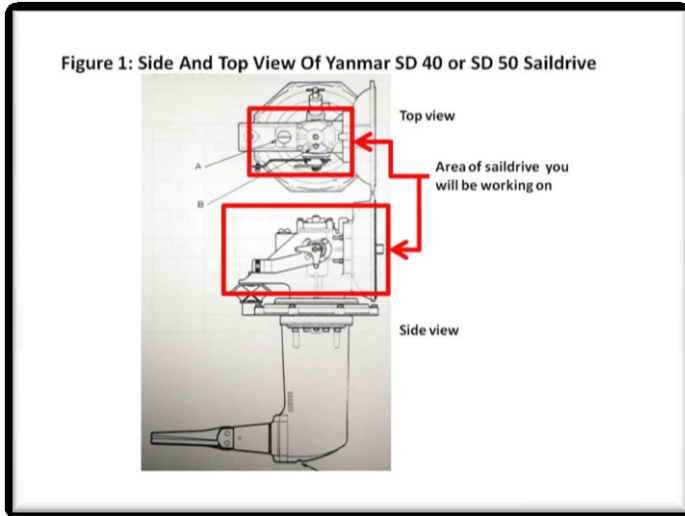
Figure 1 shows the side and top view of the saildrive and highlights the area of the saildrive you will be working on.

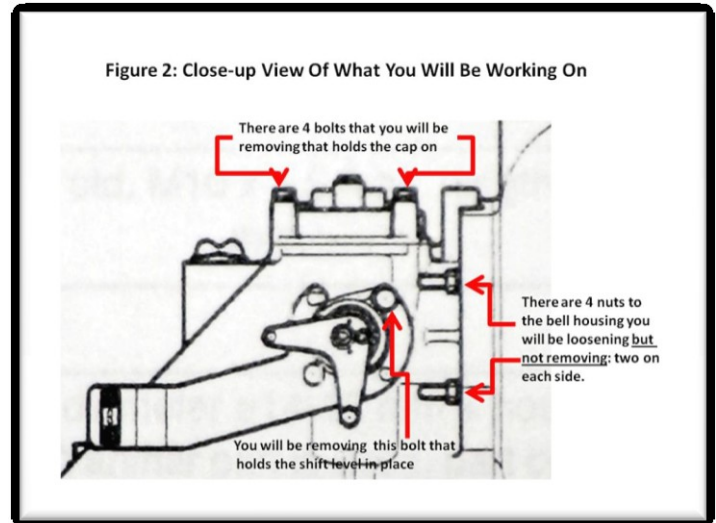
Figure 2 is a close up of the area of the saildrive you will be working on. It also shows the bolts and nuts that you will be removing or loosening. The secret of not having to separate the engine from the saildrive and then moving the engine forward is that you will just be loosening the 4 nuts at the bell housing but not removing them from the stud bolt. You then push those stud bolts forward and it backs the pinion gear and its shaft away from the drive cone

assembly and allows you to remove the drive cone assembly. You will also be removing the shift lever assembly before you remove the drive cone assembly.

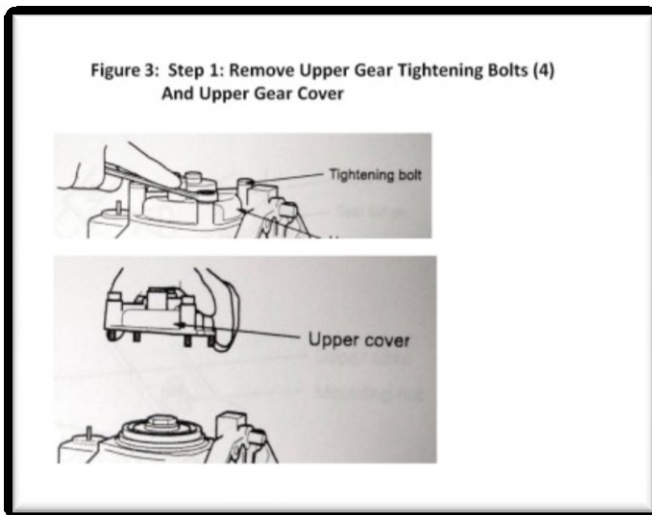
Figure 3 shows the first part of step one. Using a wrench, loosen and remove the four bolts that secure the upper cover cap. Set the bolts aside and remove the cap. Once the cap is removed, you will now want to suck or siphon out about 200 ml of gear oil from the top. You do this so that when you remove the shift lever assembly, gear oil will not run out and get things messy. Once the 200 or so ml of gear oil is removed, you are ready for step 2: removing the shift

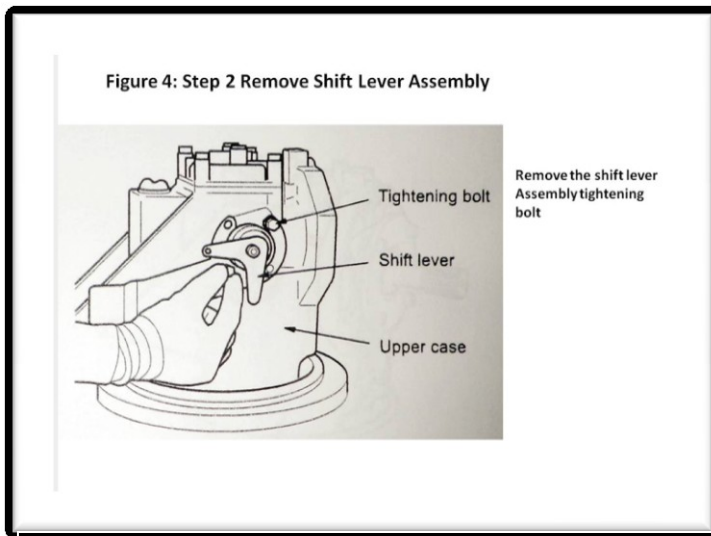
NOTE: THE HAND IN FIGURE 4 IS ON ONE OF THE BOLTS. THE OTHER IS THE BOLT THAT IS LABELED "TIGHTENING BOLT".

Now that you have the gear case's upper cover off and you have lowered the gear oil level down below the shift lever orifice, it is time to remove the shift lever assembly. Figure 4 shows what you will be working on and Figure 5 shows what the shift lever assembly looks like. The shift lever assembly is fixed to the gear case by *TWO* bolts. Use a wrench and carefully remove them. Once the bolts are removed, carefully pull out the shift lever assembly. Be careful when you do as a spring will help push the assembly out. *Also be aware that there are shims, or spacers, inside the shifter piston. This is how the factory adjusts the proper tolerances. Just be careful not to dump them out and lose them. We suggest actually wiring, taping, or otherwise keeping the shifter in place inside the cylinder, (labeled "support" in figure 5) that the piston sits in until you are ready to reassemble. As you pull the assembly out, make sure you note the angle the shifter is at. When you reinsert the assembly, the shifter will need to be at the same angle that it came out at. I plan on placing mark on the side of the housing to note the position of the shifter when I pull it out. This will tell me how to position the shifter when I reassemble it.*

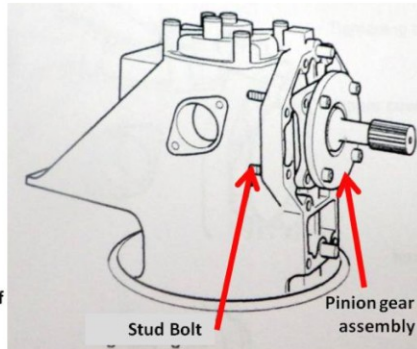
Figure 6: Step 3 Loosen Bell Housing Nuts And Push Pinion Gear And Shaft Back

Now is time to do the little secret that saves you time and lots of money. The pinion gear is what transfers the engine's torque to the saildrive and is inside the bell housing. Figure 6 shows the bell housing removed and exposes the pinion shaft assembly. Normally, the mechanic will separate the engine from the saildrive, back the engine off about six inches and back this pinion gear and shaft off. This takes about half a day of his time. However, you are smarter than that! Instead, you need to only loosen the nut that is on each of the 4 stud bolts and back them off until it they are just at the end of each stud bolt. **DO NOT REMOVE THE NUTS FROM**

This figure has the bell housing removed and shows the pinion shaft assembly. Normally, the mechanic will separate the engine from the saildrive, back the engine off about six inches and back this pinion gear and shaft off. However, you are smarter than that! Instead, you need to only loosen the nut that is on each of the 4 stud bolts and back them off until they are just at the end of each stud bolt. **DO NOT REMOVE THE NUTS FROM THE STUD BOLTS.** Next, using a hammer, gently tap each bolt to move the pinion gear assembly back a bit so you can easily remove the drive cone assembly (see next figure).

Next, using a hammer, gently tap each bolt to move the pinion gear assembly back a bit so you can easily remove the drive cone assembly.

We discovered it to be much more than a gentle tap, in fact we had to borrow a bigger hammer and used a punch to transfer the blows to the tip of the stud. The hammer could not be applied directly to the end of the stud as the housing was in the way. We also found that we had to back them out to almost their limit (leaving the nuts on) to extract the Drive Cone Assembly.

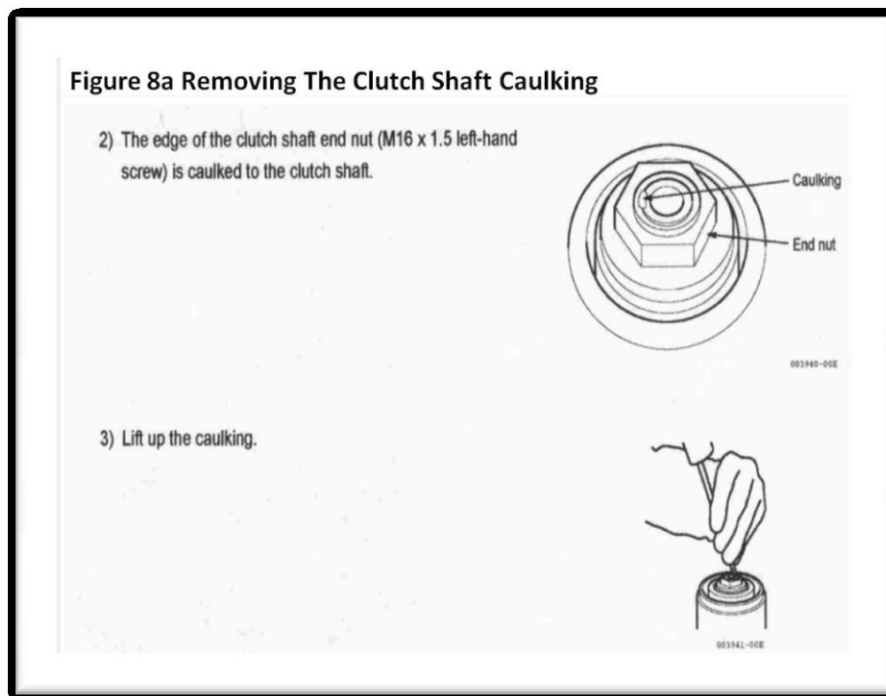
This is what the drive cone assembly looks like once it is removed.

Once you have removed the drive cone assembly (Figure 8) you need to insert the clutch shaft into a spline socket so you can insert the socket into a vice without damaging the splines on the shaft. I am not sure what size of spline socket you need but you can buy a universal spline socket set from Sears for under \$40. Or, you can buy Yanmar's "Special Tool A" but it is very expensive.

nut, part #196324-04380 as you will have to destroy it when you remove it. Let me explain. On the nut is a special "raised ring". Once you torque the nut back onto the shaft you will need a punch to hammer the ring into a keyway on the shaft. To remove the nut you have to pry this peened area out of the keyway. You want to remove as much of what Yanmar calls the "caulking" (peening) in their repair manual, or else you will damage the threads of the shaft when you remove the nut. At the factory Yanmar overdoes the peening such that it is almost impossible to

get it all out of the keyway. We did do some damage to the threads but were able to repair them with a triangle file. When we peened it ourselves we did it such that the side of the peening that would prevent the nut from backing off (remember it is a left hand nut so you remove it with a clockwise motion, the opposite of common nuts) is wedged in more aggressively than the opposite side. That will prevent it from backing off, which is what this "caulking" is for, but will allow us to get the chisel under the caulking to pry it up next time. When we do our starboard cone I plan to use a drill to reduce its size and a Dremmel tool to get more of the "caulking" out of the keyway before we back off the nut. Dave suggests you use thread lock but we saw no signs of thread lock from the factory and decided to just use the peening. A note on removing the nut, it is very difficult. We ended up at a machine shop and they could not break it loose with common wrenches or sockets. They ended up using a pneumatic impact wrench. In hind sight I think it was because they did not do a good job

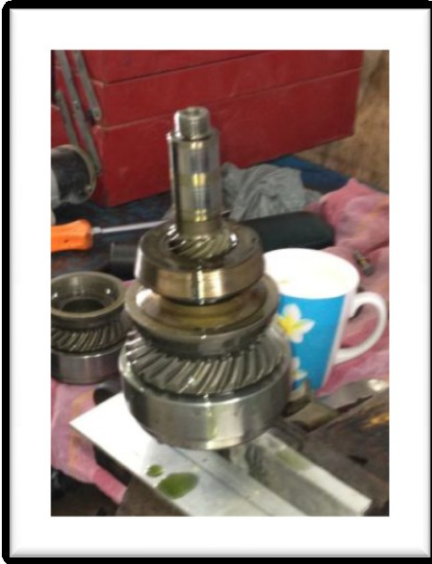
In the absence of the above, I used 2 pieces of aluminum section inserted into the vice jaws as shown in the pic....aluminum is softer than the spline...the spline wasn't damaged at all.

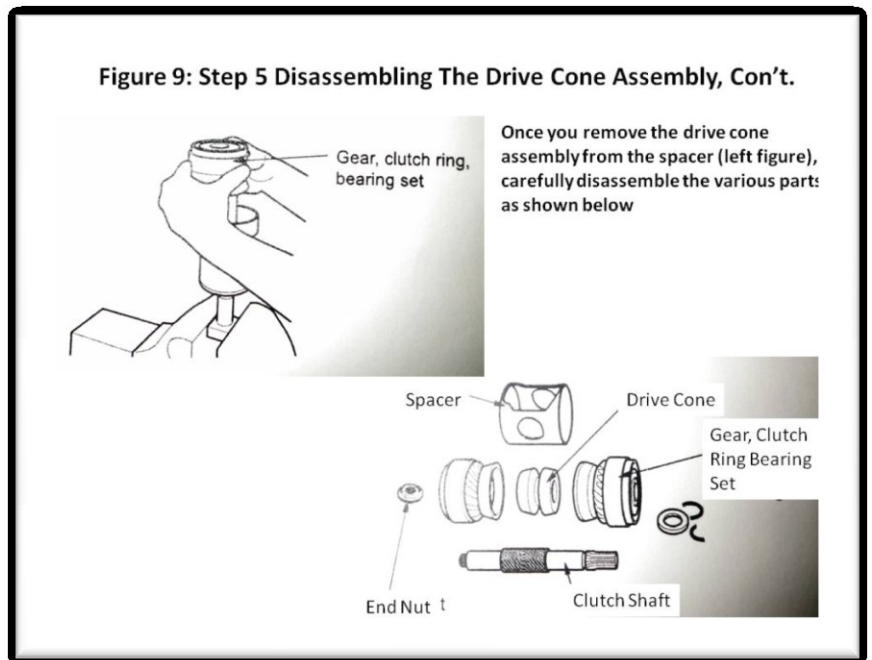
With the nut off, you can slip off the spacer and disassemble the assembly (see Figure 9).

A word of caution here. The circlip semi-circle rings you see in the picture will fall out without you knowing it if you are not careful. You can guess how I know this now. If you lose them like I did you will need two of part #196322-04370 as they are sold individually, not as a set. That number has been superseded by part #04371, but they don't have 04371 in the US as of 9/9/11. So if they tell you they are only available in Japan ask them to look for 04370.

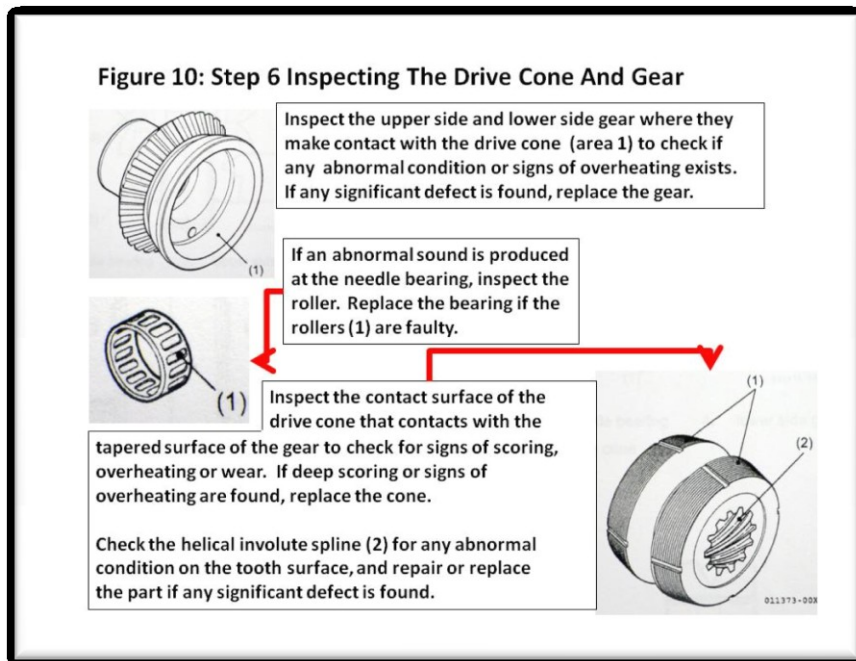
Once you have disassembled the drive cone assembly, inspect the upper side and lower side gears where they make contact with the drive cone to check if any abnormal condition or signs of overheating exists (see area 1 in the upper left hand picture in Figure 10). If any significant defect is found, you should consider replacing the gear.

Inspect the roller (see the middle picture in Figure 10) and if an abnormal sound is produced at the needle bearing this means the rolls are faulty and the bearing needs to be replaced.

Inspect the surface of the drive cone that contacts with the tapered surface of the gear to check for signs of scoring, overheating or wear (see the bottom right picture in Figure 10). If deep scoring or signs of overheating are found, replace the cone.

Check the helical involute spline (2) for any abnormal condition on the tooth surface, and repair or replace the part if any significant defect is found (see the bottom right picture in Figure 10).

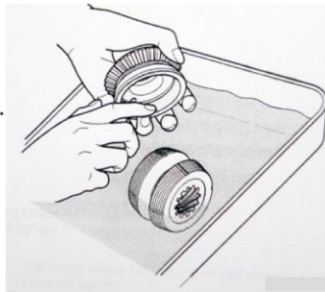
Figure 12: Step 7 Lapping Procedure For Drive Cone, Cont.

After lapping them, wash them with kerosene or similar solvent. They need to be washed thoroughly so no grit is present (see Figure 12, upper picture). When assembling the drive cone, be sure to check its alignment. The larger diameter 044 face should be on the lower gear side (see Figure 12, lower picture).

After lapping them, wash them with kerosene or similar solvent. They need to be washed thoroughly so no grit is present.

When assembling the drive cone, be sure to check its alignment. The larger diameter 044 face should be on the lower gear side.

Pay close attention to the picture at the bottom of Figure 12 (above), it is important that the clutch be installed correctly as it will fit just fine upside down but I'm guessing it won't work, at least very well. Once it is off you will see it is different on either side. According to figure 12 the wider faced side goes down toward the spline end of the shaft. The same is true of the spacer, but you can tell from Dave's picture in Figure 8 which way it goes. The small hole above the shifter opening is the clue to verify with, it goes toward the nut end of the shaft.
