# HR 37 "Mia Maria" in her preferred element

Delivered on  
13th May 2008

# Delaminated hull!?

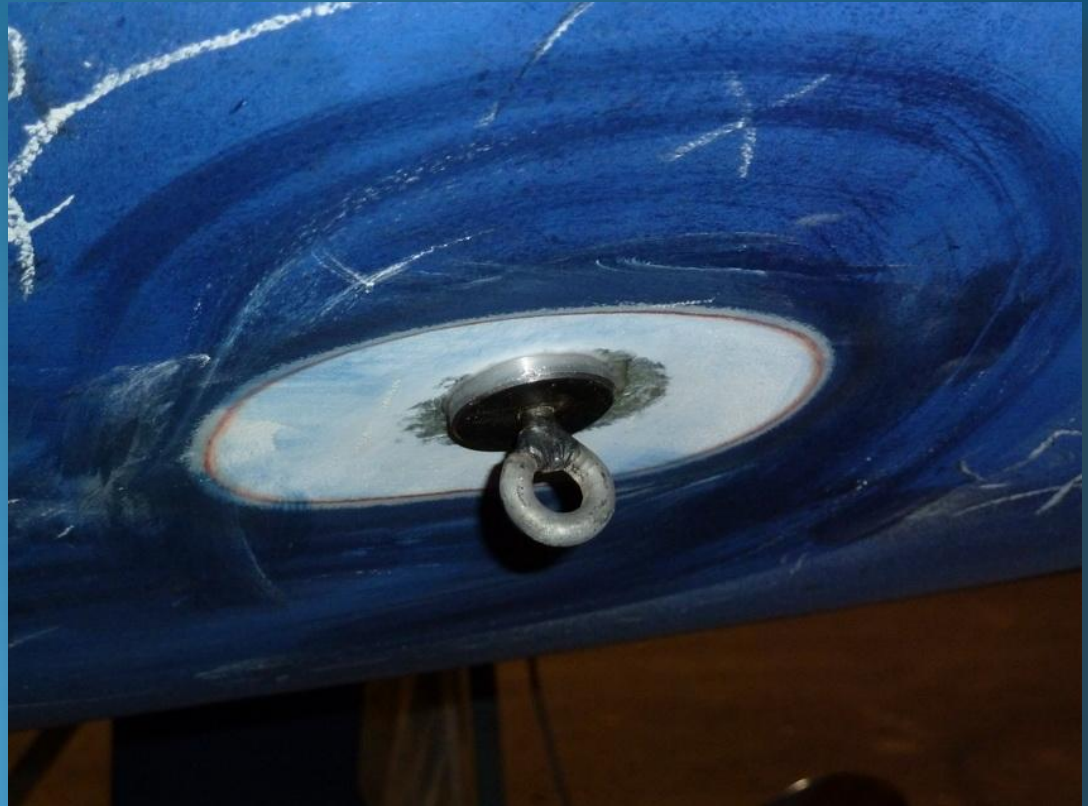
# Drilling of disc in the hull 14/06/2010

Drilling was done to predetermined dept by a new hole-saw without center drill. Glued, turned and tapered iron plate served as an accurate guide controll.

The trust was beset by a threaded rod and nut util failure occured.

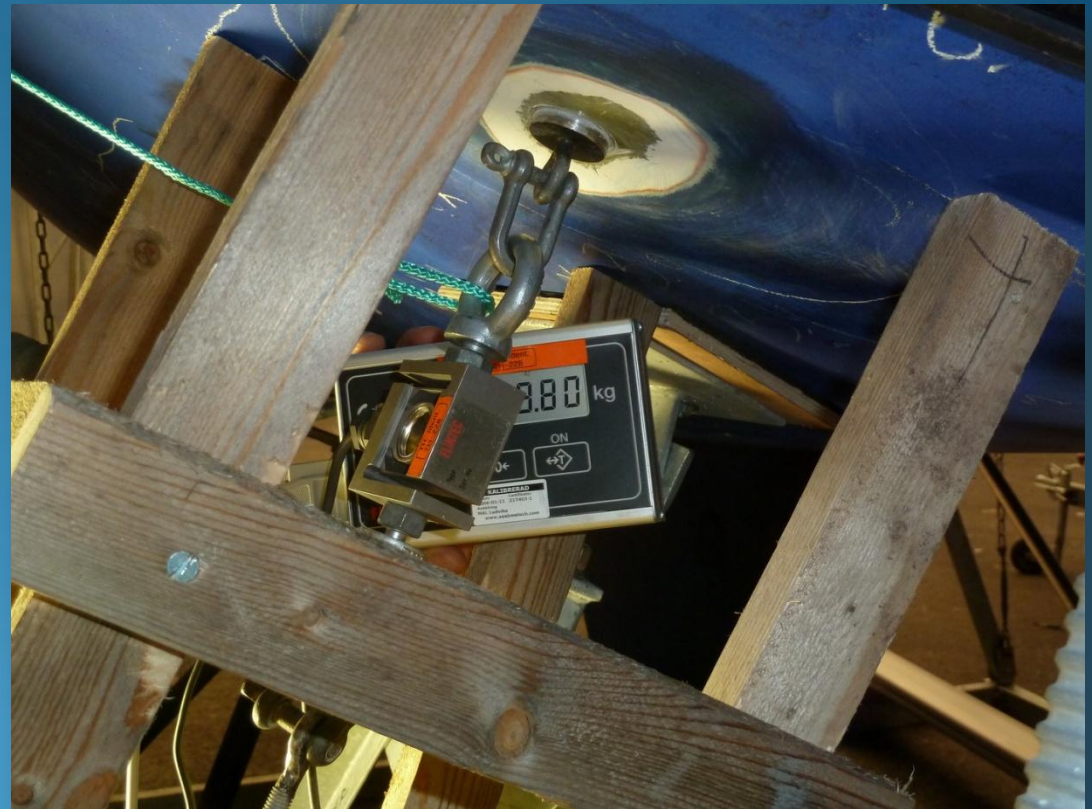
# Drilling of disc plugging in the hull

*Three tensile tests perpendicular laminate have shown a tensile strength between 0 to 1,5 Mpa. This is an "tenfold" less of than you would expect from a composite design for this class of sailing boats. Ultrasound investigation shows that poor adhesion can be expected in large parts of the hull. The examinations made show that the hull of the HR-37 No 168 is substandard from strength point of view, especially when it comes to long term performance"*

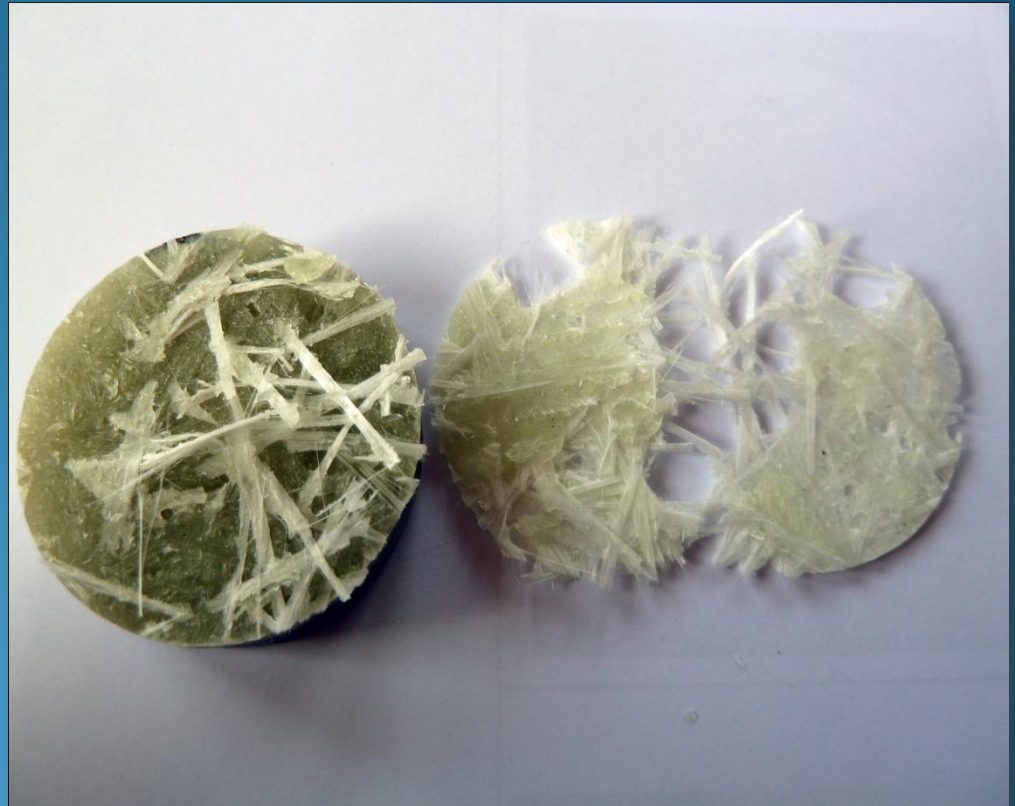
Drill Plug no 3. Parts that came out during the tensile test..

- Hull: 0-14% of minimum ultimate tension.
- Fracture surface There are very few fibers and polyester without fracture surface.
- Bending stress: Increases by 80% compared to a homogeneous hull
- Hull Strength: Reduced to almost 50% of normal value
- Grounding: Can mean consistent cracks in the hull with water flooding as a result
- Teature: The boat is classified as unseaworthy

Note the difference in the fracture surface.  
Prof. K-E Olsson: in a "healthy" laminate the fracture surfaces have similar appearances

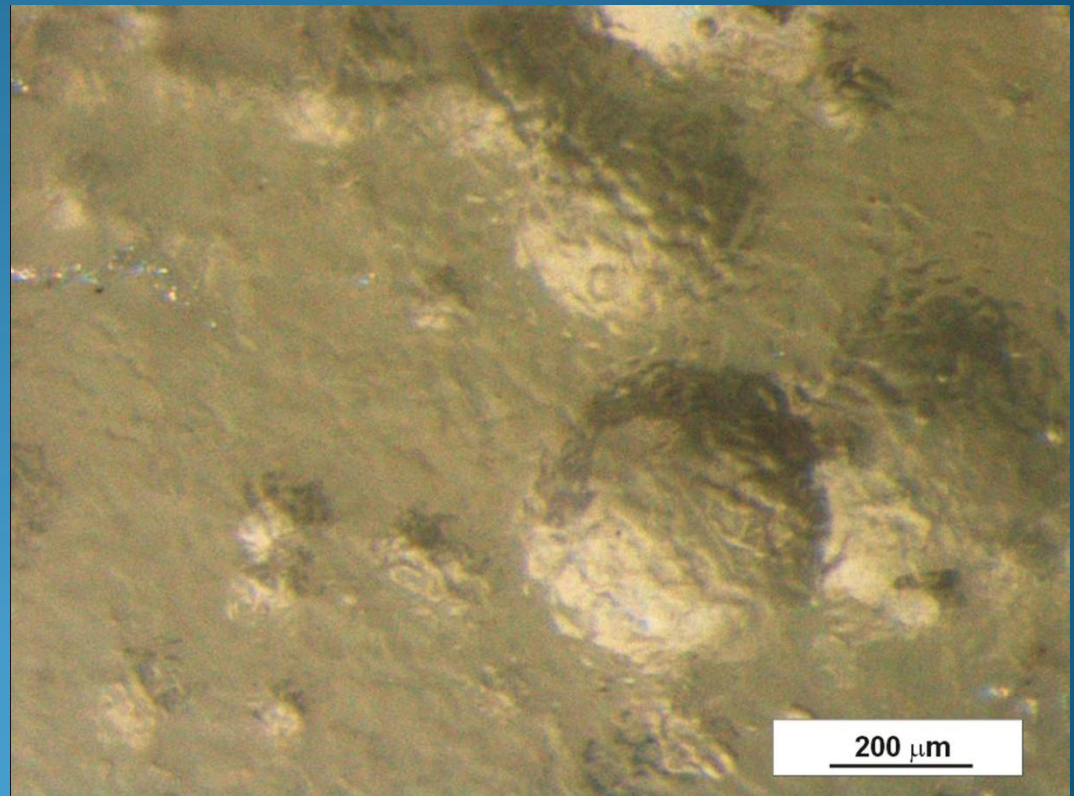
# Test conducted by Associate Professor Anders Sjögren

The rugged structure that was shown  
on the previous image is not common  
for (the) fracture surfaces.

New fracture surface was therefore  
created by cleaving a part of the inner  
hull disc.

The result can be seen in this picture.

The breaking surface is almost  
completely smooth, which is normal.  
The rough surface of the previous  
image thus indicates that the bond  
between the two parts of the hull disc  
was poor (nonexistent?)

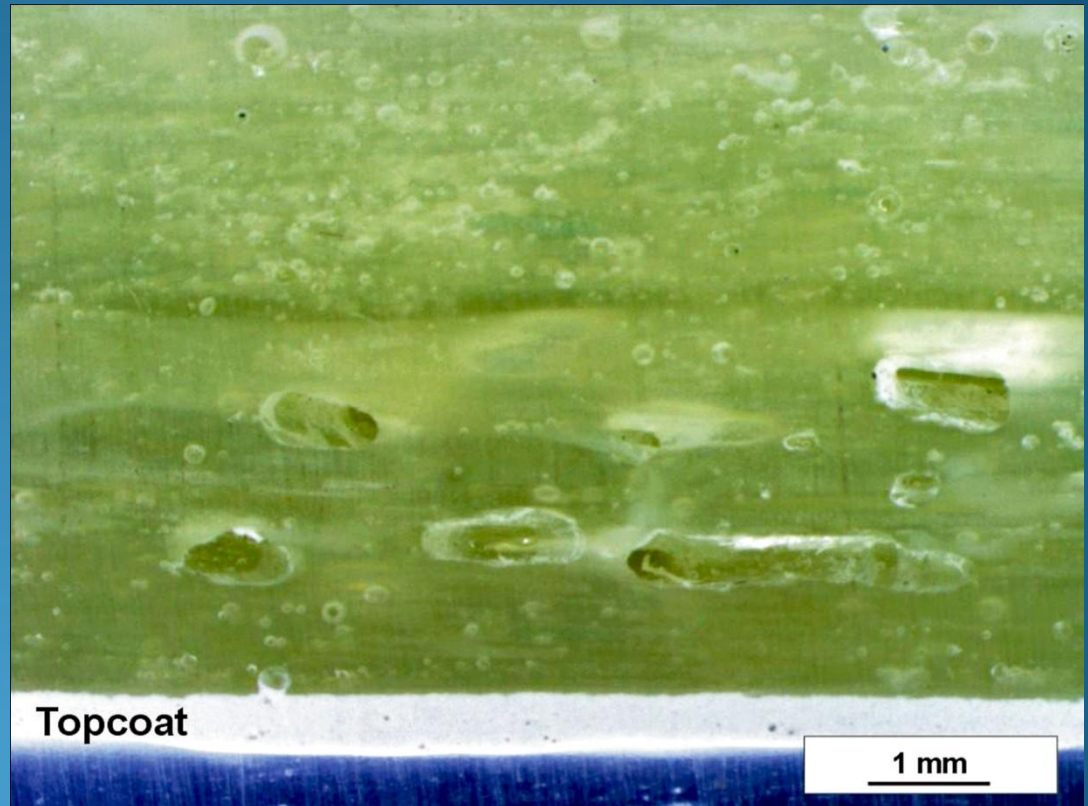
# Test conducted by Associate Professor Anders Sjögren

Note the porosity.

Quality Construction as  
advertised by  
Hallberg-Rassy !!??

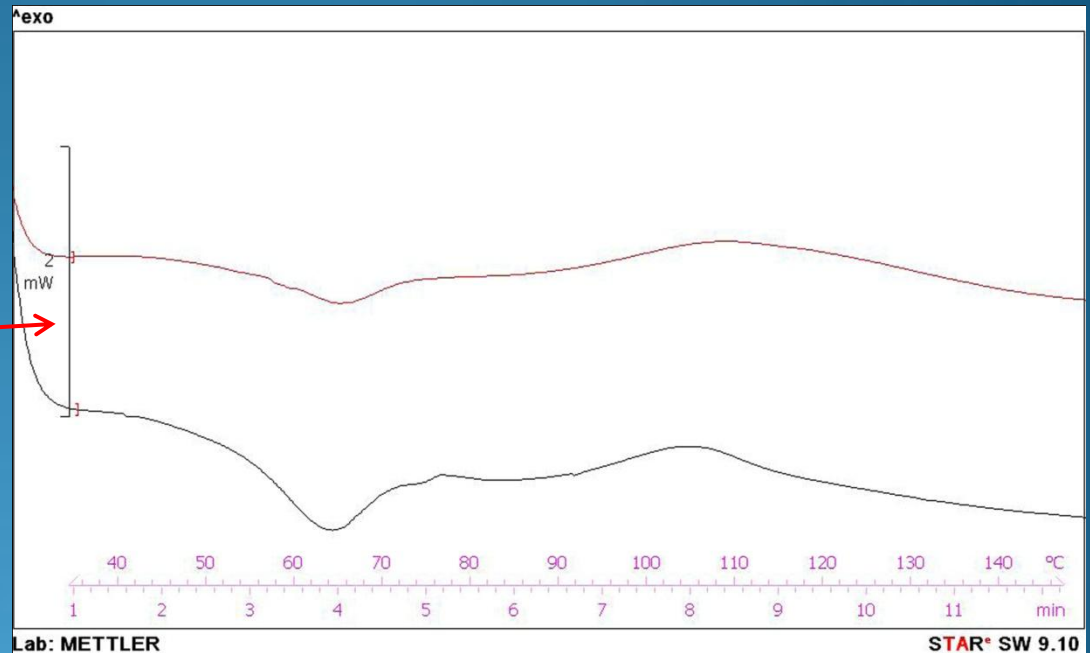
# Analysis of the disc that "looked" flawless when drilling

This disc, which was drilled out with a new Starret saw looked absolutely flawless and could not be divided by finger pressure.

The disc was to be used for determination of por content. During analysis of material, a crack measuring 2 / 3 of the surface was revealed.

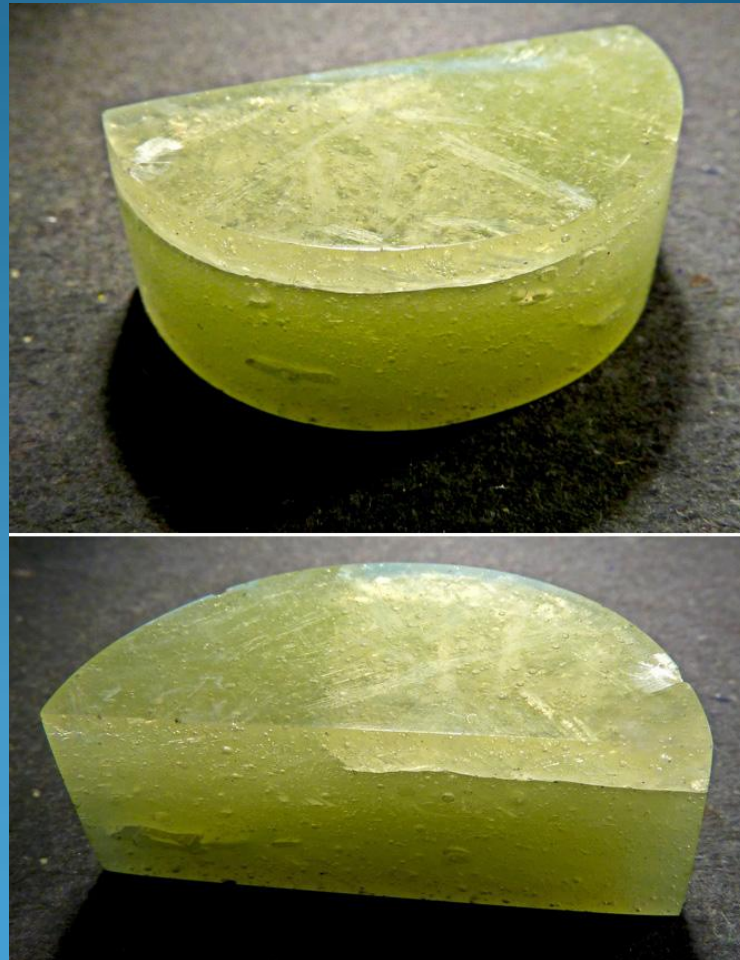
# Air in the laminate

Air in laminate: content 6.1 vol

**Note:** The glass content is very high. A heavy fiberglass in density 2.55 gr/cm<sup>3</sup> were used and have been difficult to impregnate the matrix.

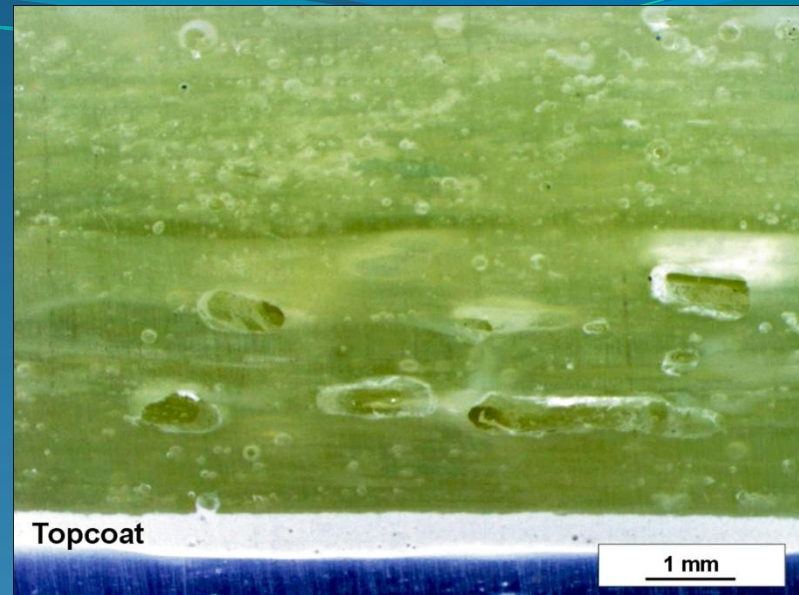
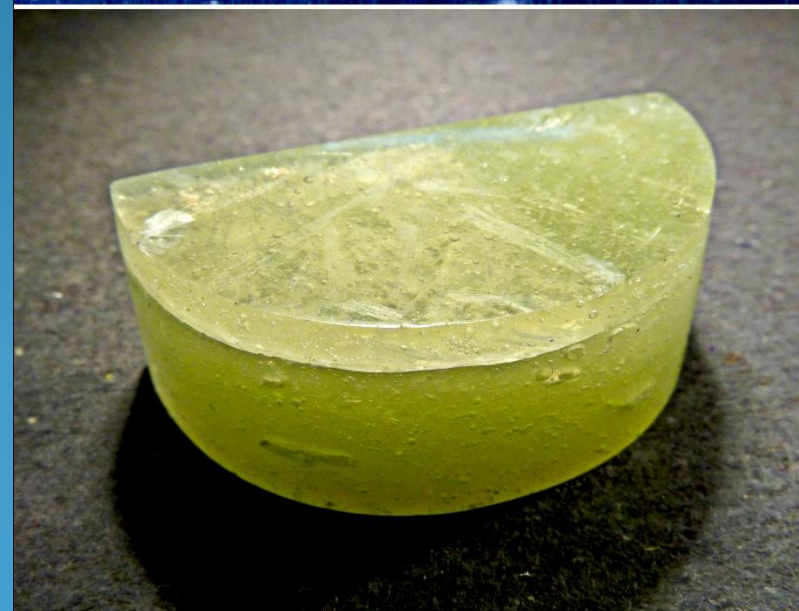
# Hallberg-Rassy's own evidence of a good hull

A disc with depth 25,3 mm.  
Our hull is 12-13 mm thick.  
Is this from our boat??

**These states the disc wholly  
inadequate in terms of  
adhesion between layers**

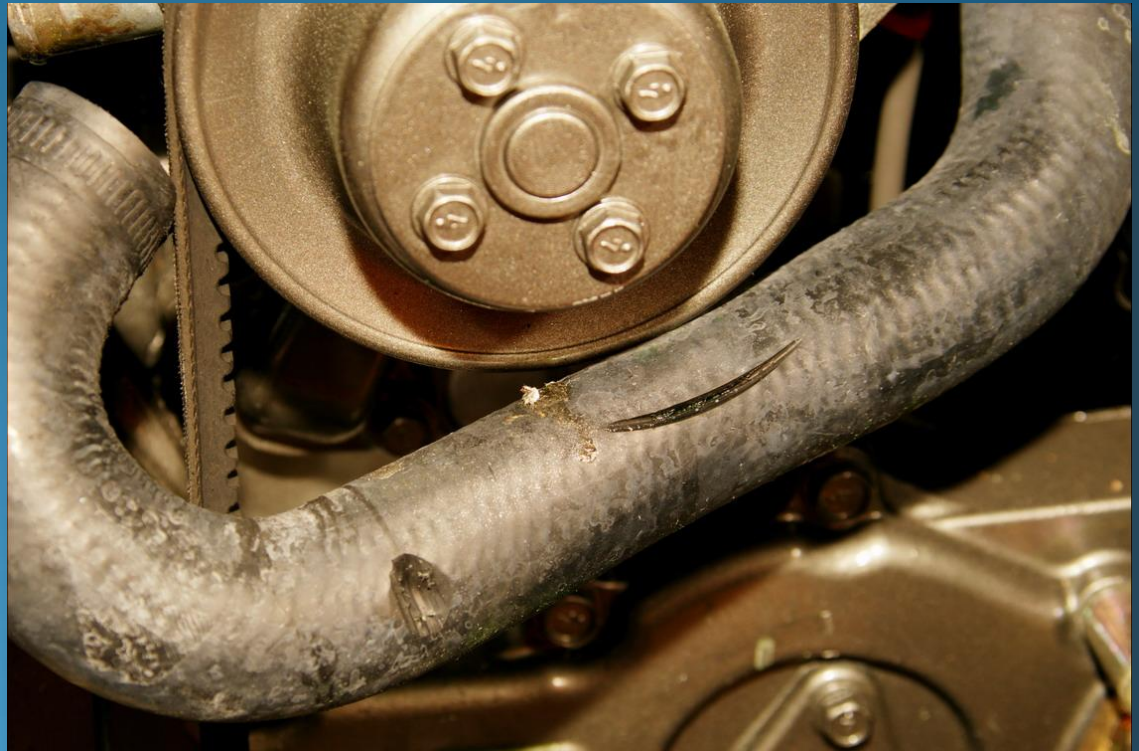
# Engine problems from the day of delivery and all of 2008

The hose to the cooling was incorrectly fitted causing the belt and the pulley to rip the hose. Towing in to Bullandö Marina

Bullandö Marine put a temporary binding  
View glycol in the hole under the binding

The entire engine compartment dirtied by glycol fog.

Required two days to dry off.  
No help from HR

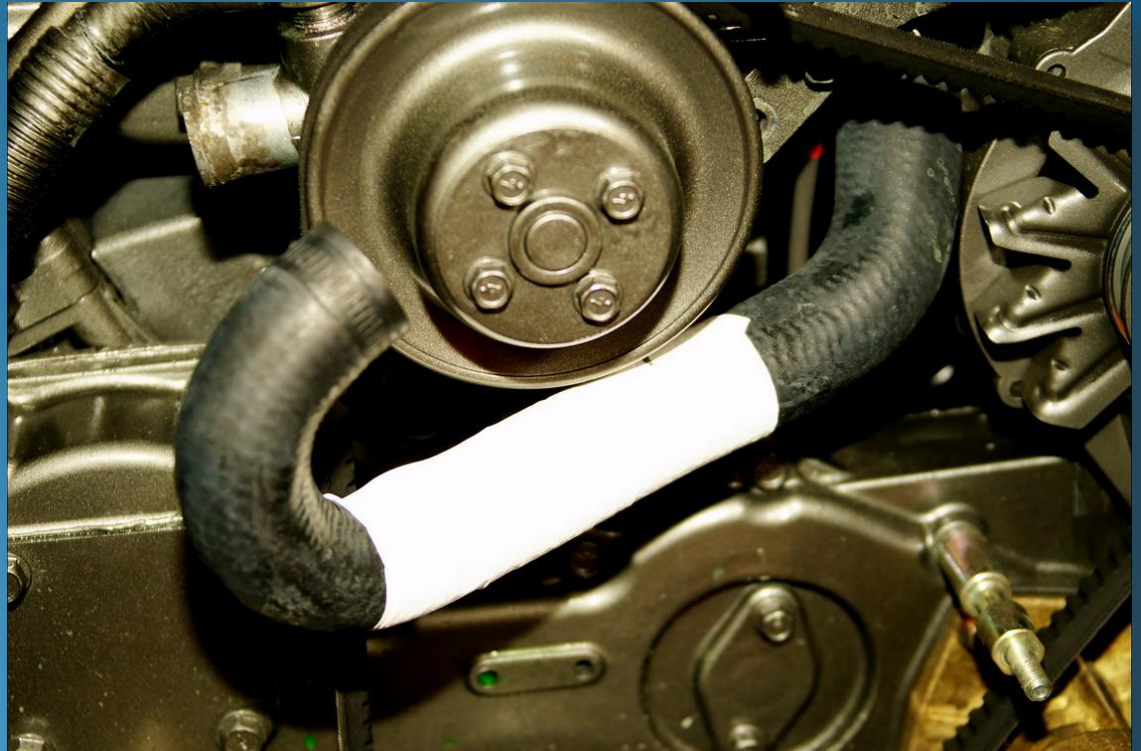
# Engine problems from the day of delivery and all of 2008

The provisional binding (dressing) lasted (kept) 1 NM.

I was again drying glycol-water throughout the engine room when I was not browsing through the phone book to call for help from Yanmar .

There is still glycol water oozing that must be wiped away.  
The engine room was repainted with topcoat to get it clean.

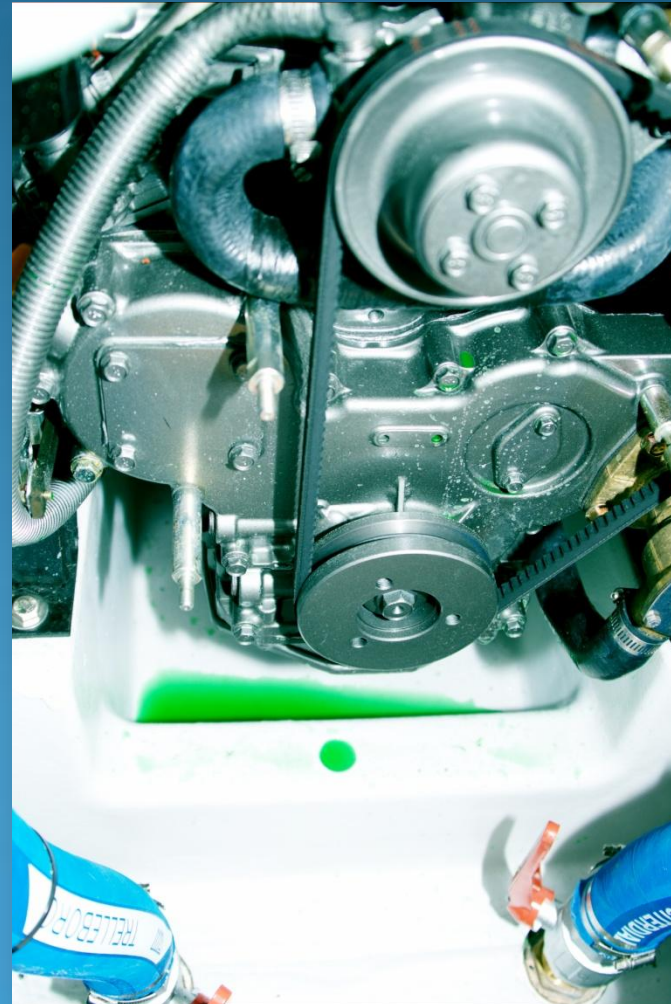
# Engine problems from the day of delivery and all of 2008

After a few more days at Bullandö Marina we got hold of a Yanmar guy on vacation 40 km from Stockholm. He had a tube in the right dimension and made a temporary repair.

This tube was later replaced by Kamm's AB in Karlskrona. I.e. yet another workshop visit.

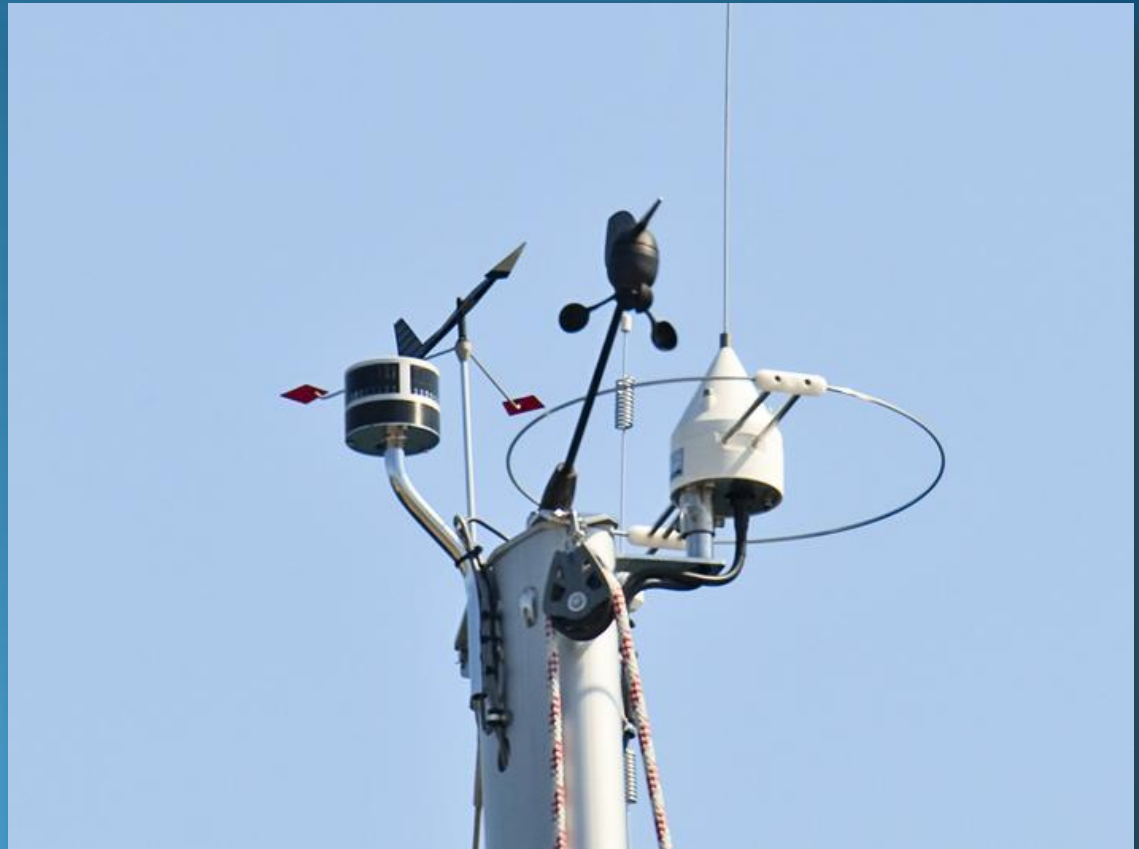
# Top lantern with 19 degrees dead sector

"Re-mounting of the Lopolight is neither possible nor approved by the Hallberg-Rassy. Either you accept the installation as it is, or we let the purchase of Lopo lighten go back. You should in that case return the material latest December 31, 2009 and you will then be refunded purchasing sum for this equipment."

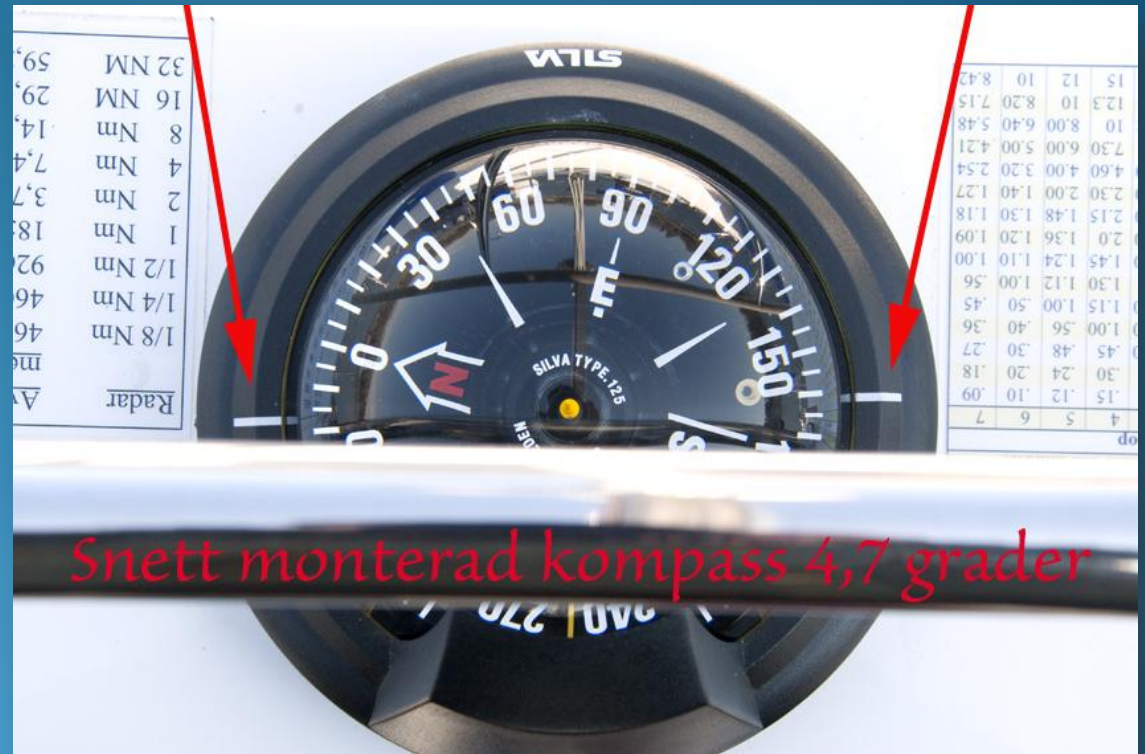
# Oblique-mounted Compass

When removing the compass, it was found leaking.

Had myself to locate the supplier in Sweden, and send them the compass to get it replaced.

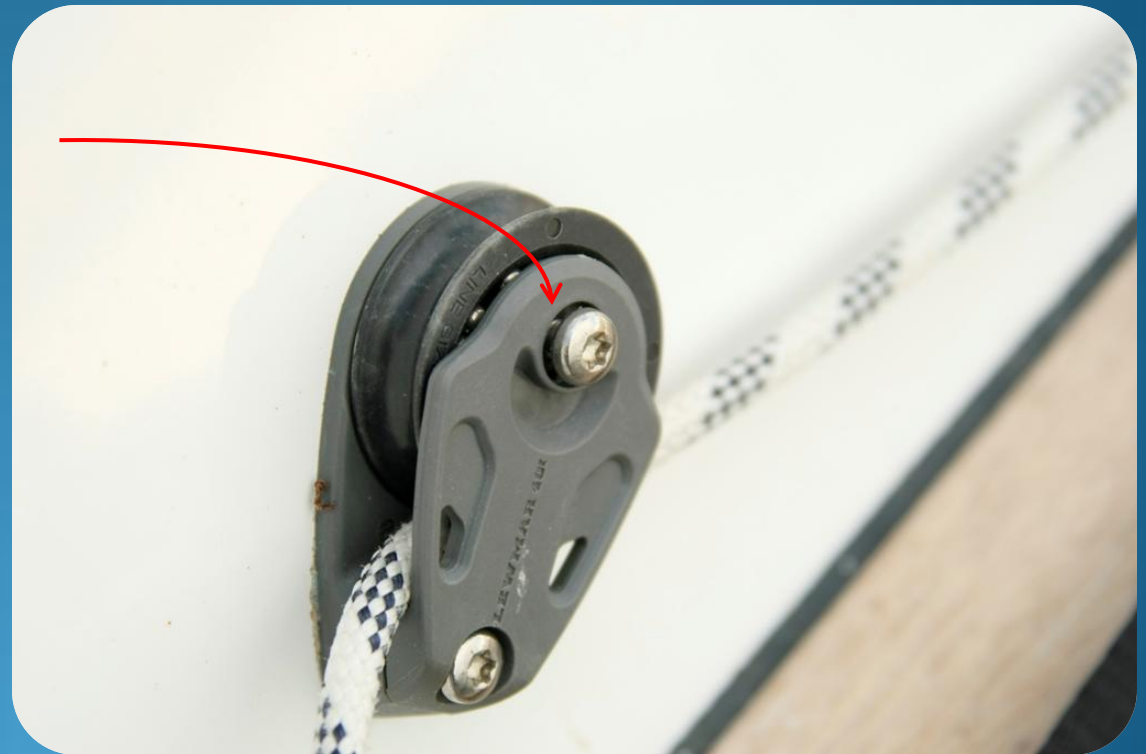
# Lead Blocks sb side not fastened

It turned out that there had never been neither washer nor bolt to this fairlead!

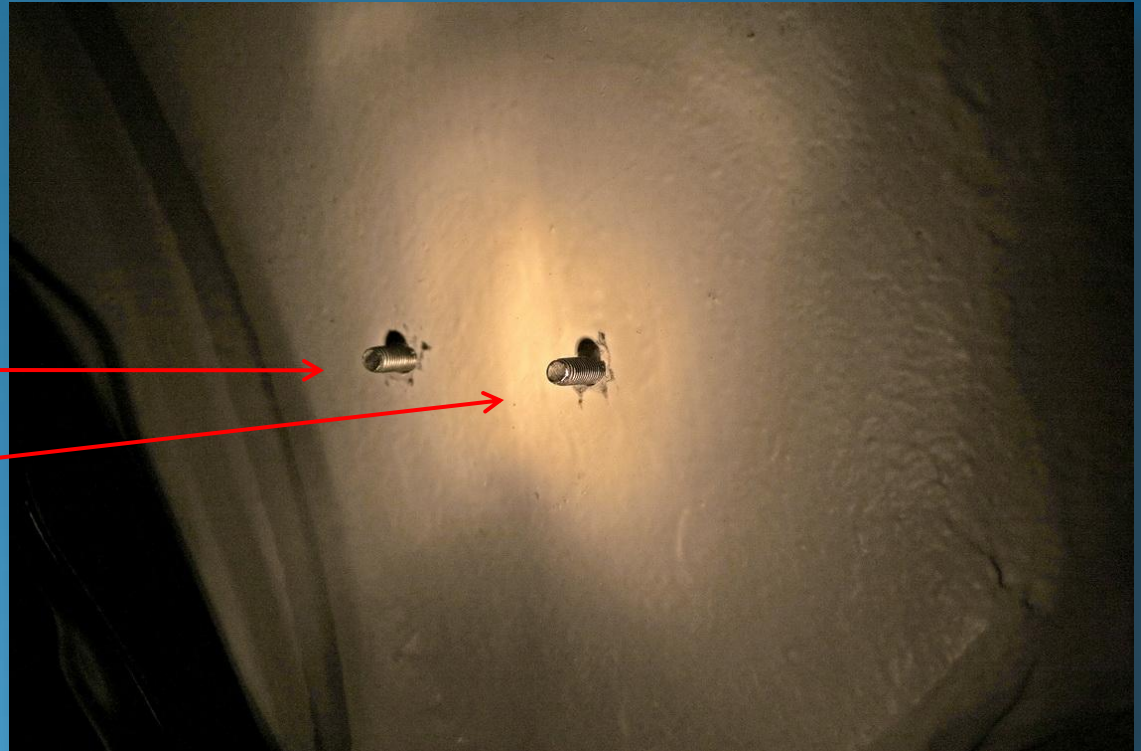
# Cockpit cover – image 1

The fitting was not the best!

Rossy Kapell has fixed a bit, but says:

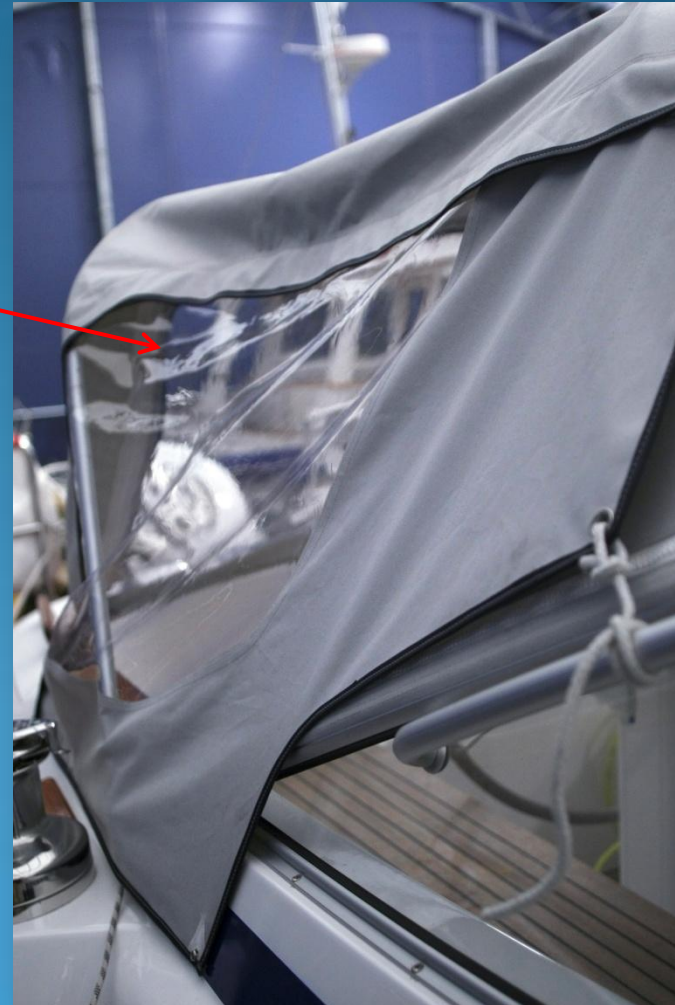
# Cockpit cover – image 1

The fitting was not the best!

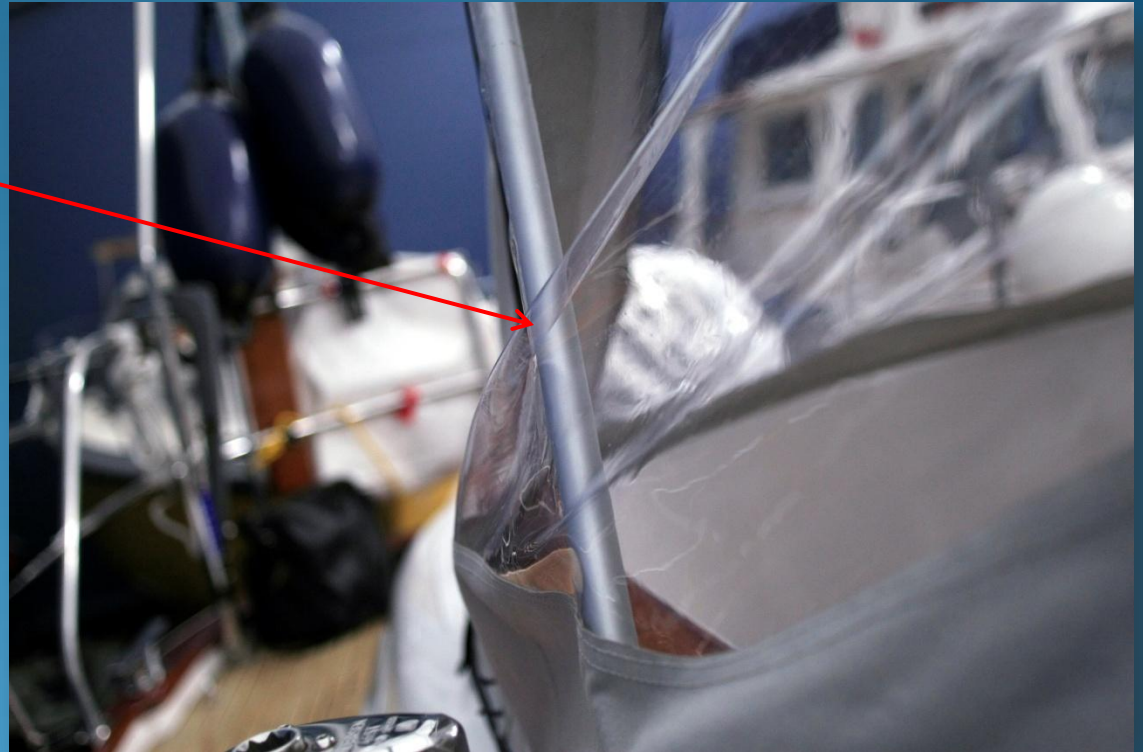
# Sprayhood

Spray hood box had crush damage in the "glass" with two small holes that were remarked upon in the port of Ellös at delivery.

Afterwards, HR / David Bourne says that the notes are missing and that the damage is a normal fold.

Rossy Kapell had to change the glass at our expense

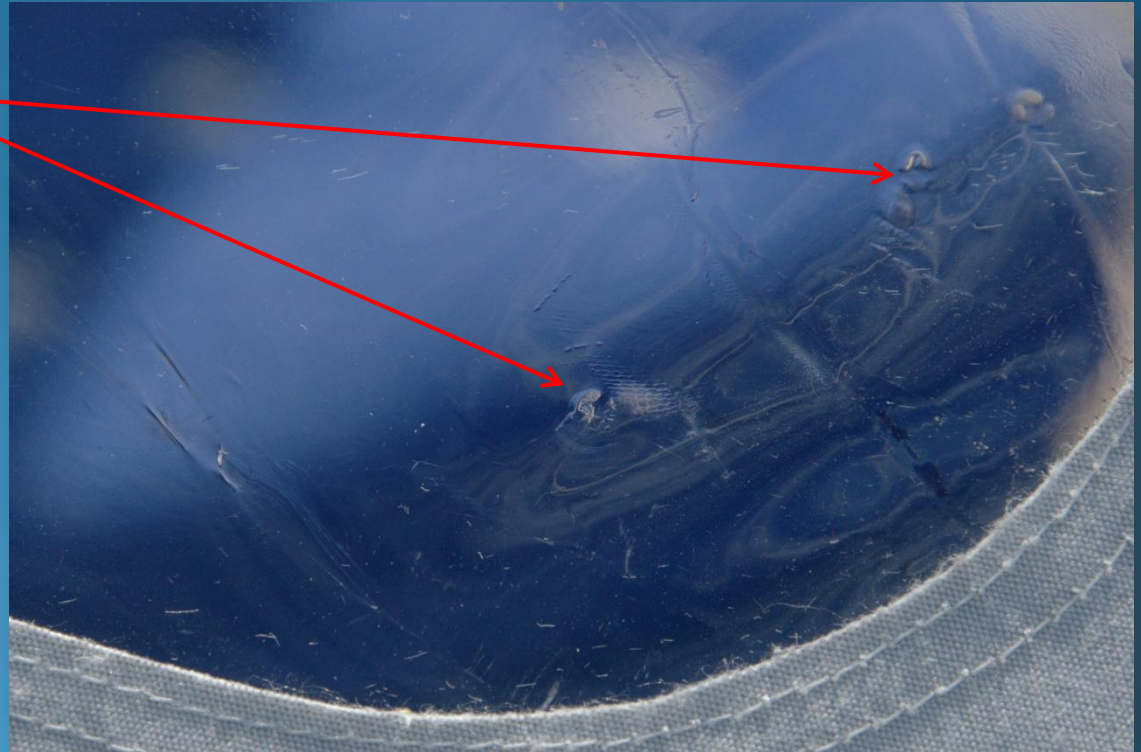
# Sprayhood

But even the spray hood had its shortcomings.

After the rain all wood and the instruments had to be removed and dried.

Impregnating liquid was purchased and the covers were treated - all at our own expense

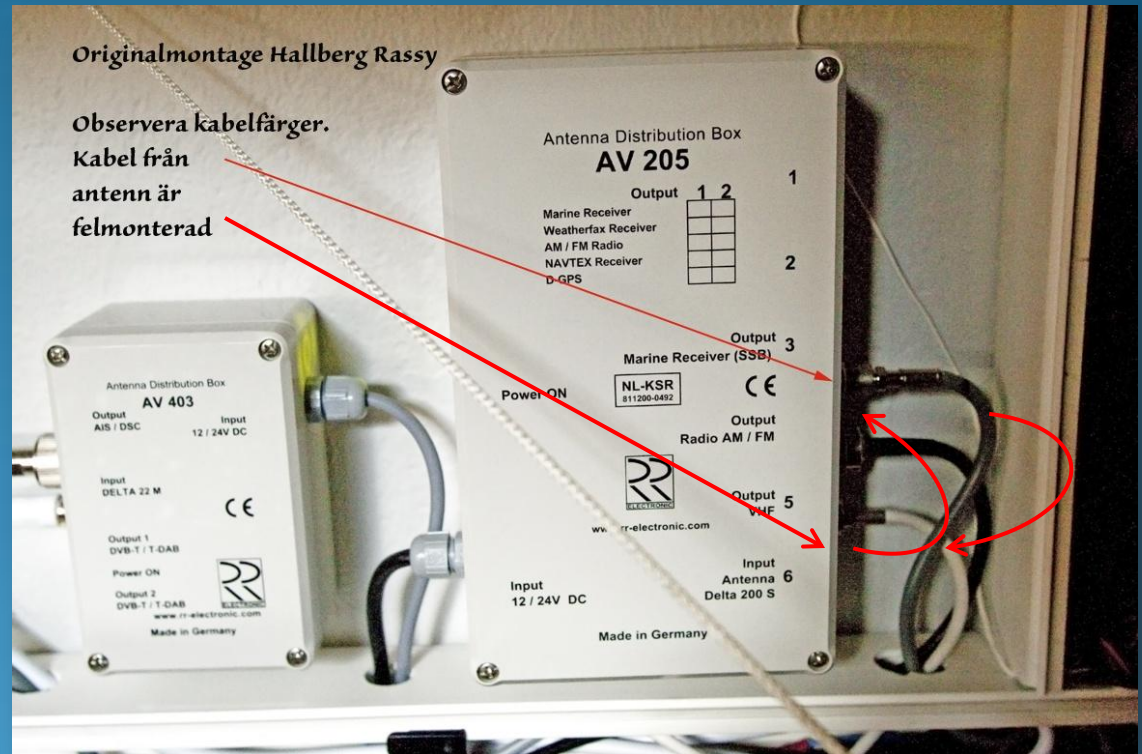
Arken Marine in Karlshamn was given to investigate. It turned out that the HR had mounted two cables wrong.

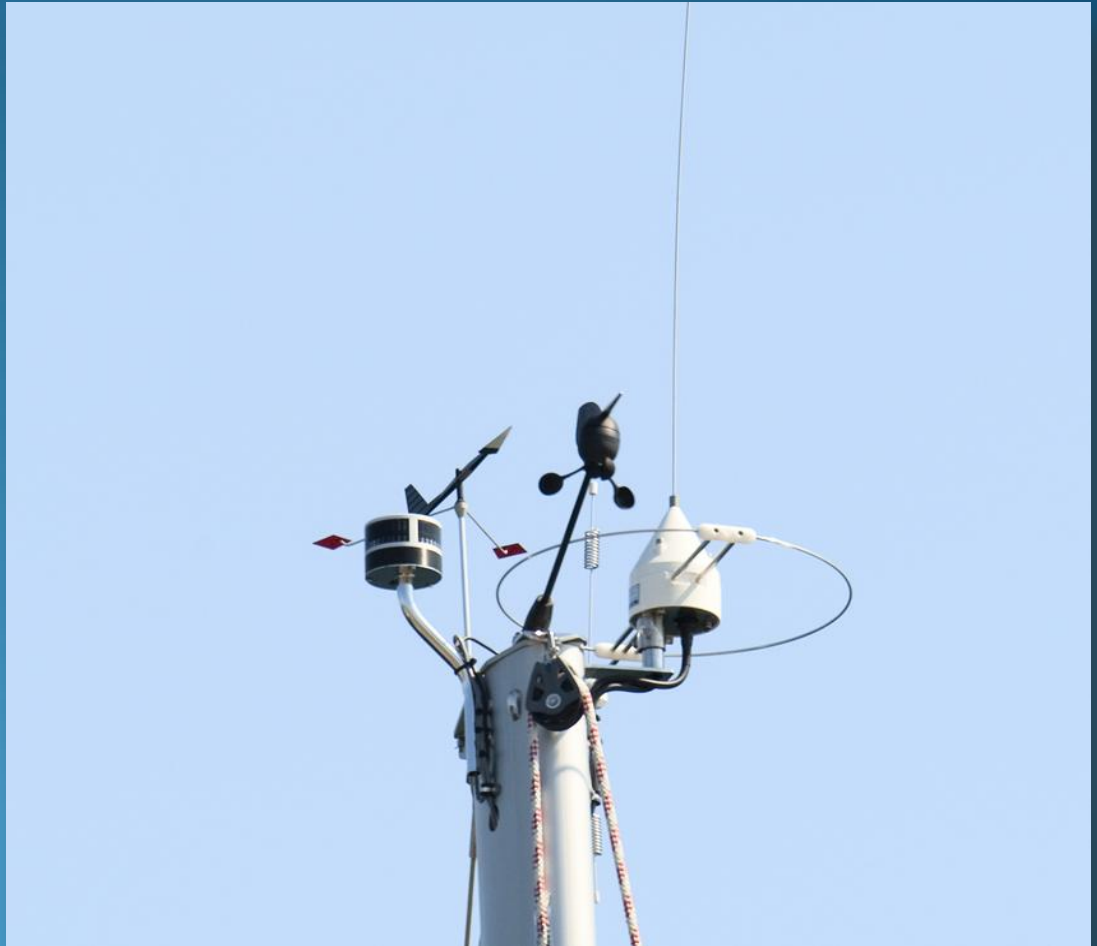
# Antenna och Antennabox

HR / David Bourne says in the phone when we call from the boat that "the cause is lightning = no warranty"! This response without survey!

*Note also how the antenna obscures top lantern*

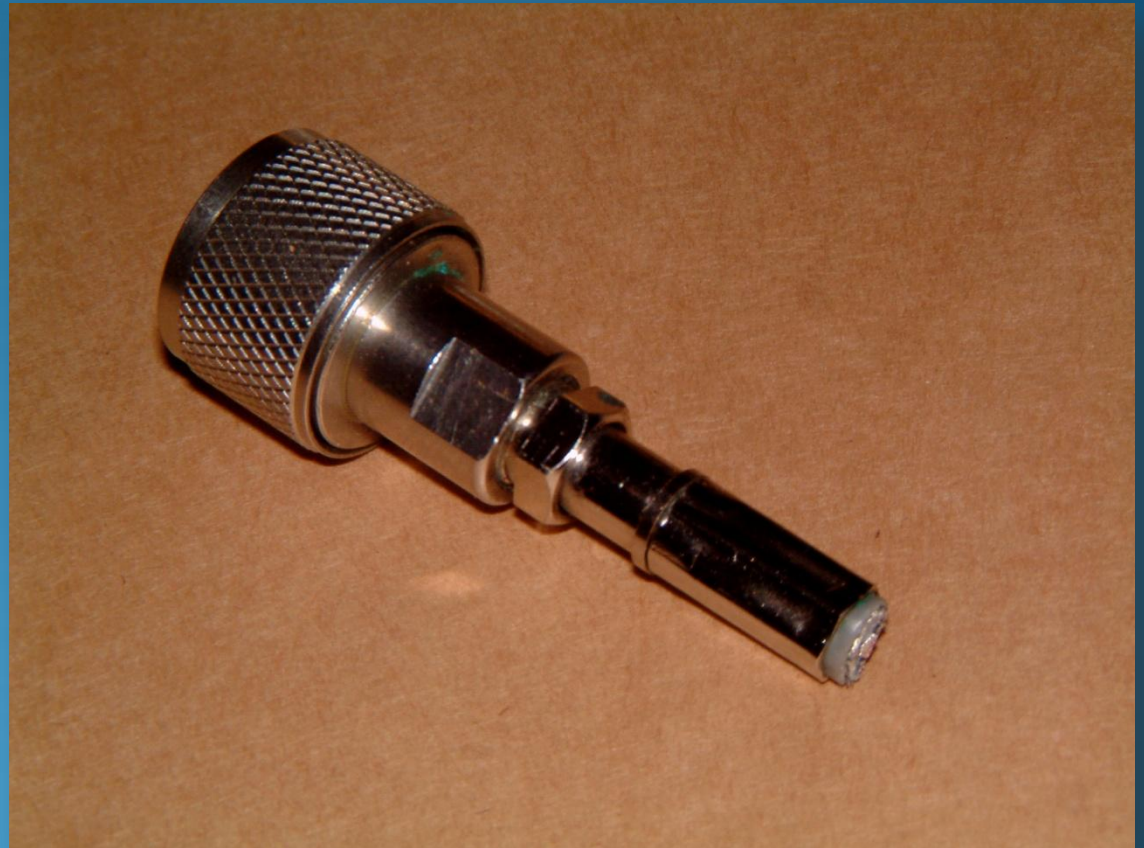
# Antenna Connector for mast base

"Arken Marin" went on looking further and found that the inside of the cable splice in the mast base was all green of corrosion. He did not know the reason. The plug was replaced, and then everything worked properly.

In Malmoe the TV component was to be tested. Did not work. Limhamn's shipping trade had to change the second coaxial connector, which also was green of corrosion.

Did not work anyway.

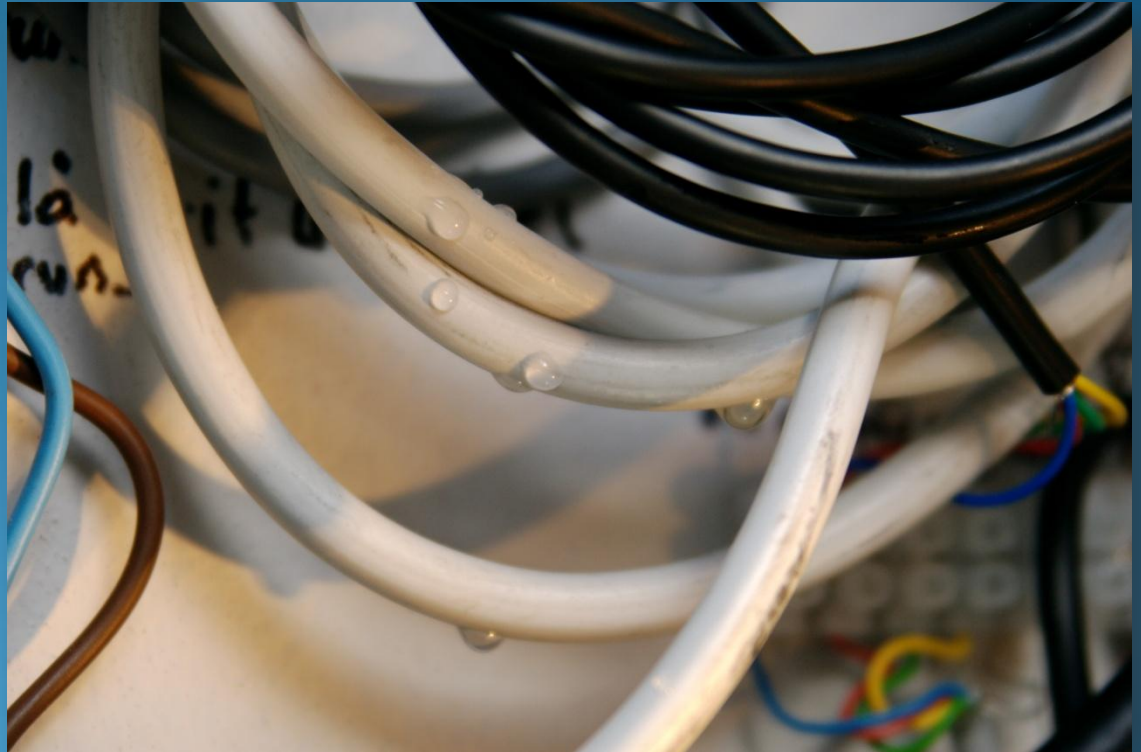
# Antenna Problems again

At the next rainy weather the cause of the corrosion of coaxial connectors was found.

All cables were wet inside the control cabinet under the mast base.

Investigation showed that the water went inside the cable housing from the HR mounted Lopolight top lantern.

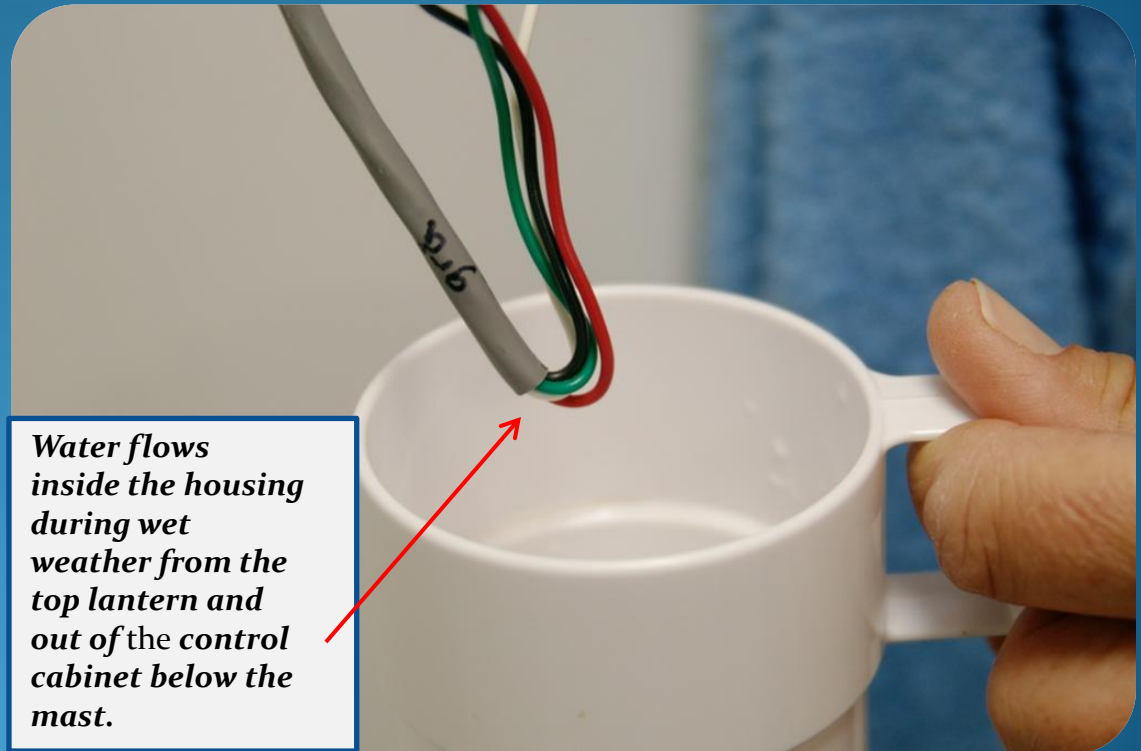
# Water in the control cabinet from cables to the top Lantern

"It is normal to expect that a lantern-cable will lead moisture and condensation and that this should not be considered as a fault."

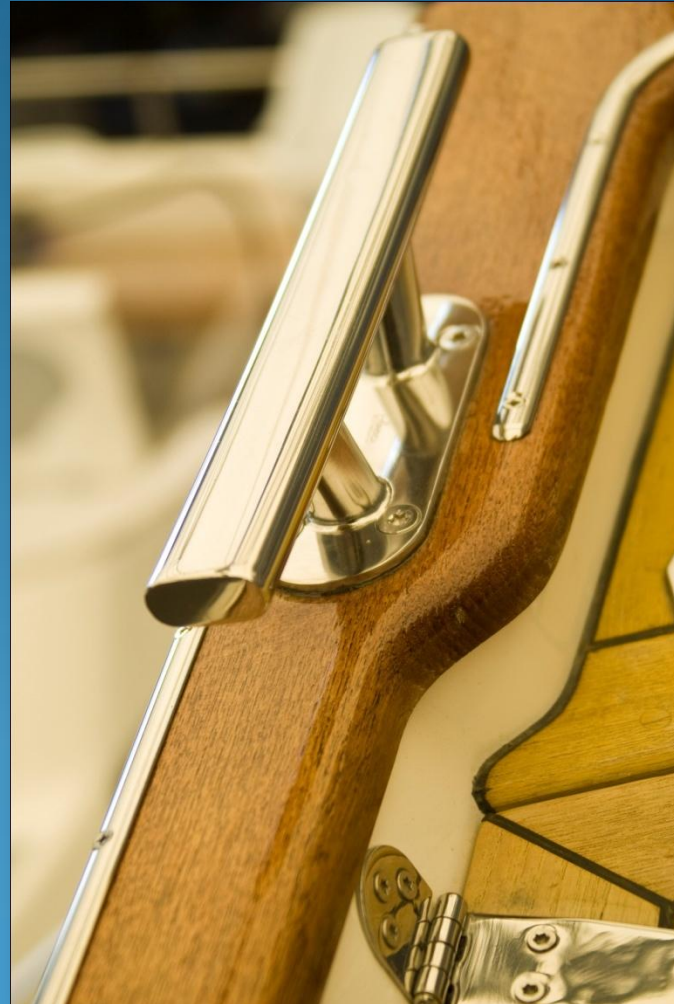
# Why is the rail bar painted?

After rain or sailing, there was water under a number of teak plugs in rail bar. The plugs swelled up. A number of plugs were replaced and the rail bar painted to avoid having black patches around each plug caused by poor mounting and gluing.

Also a number of teak plugs on the deck has been replaced

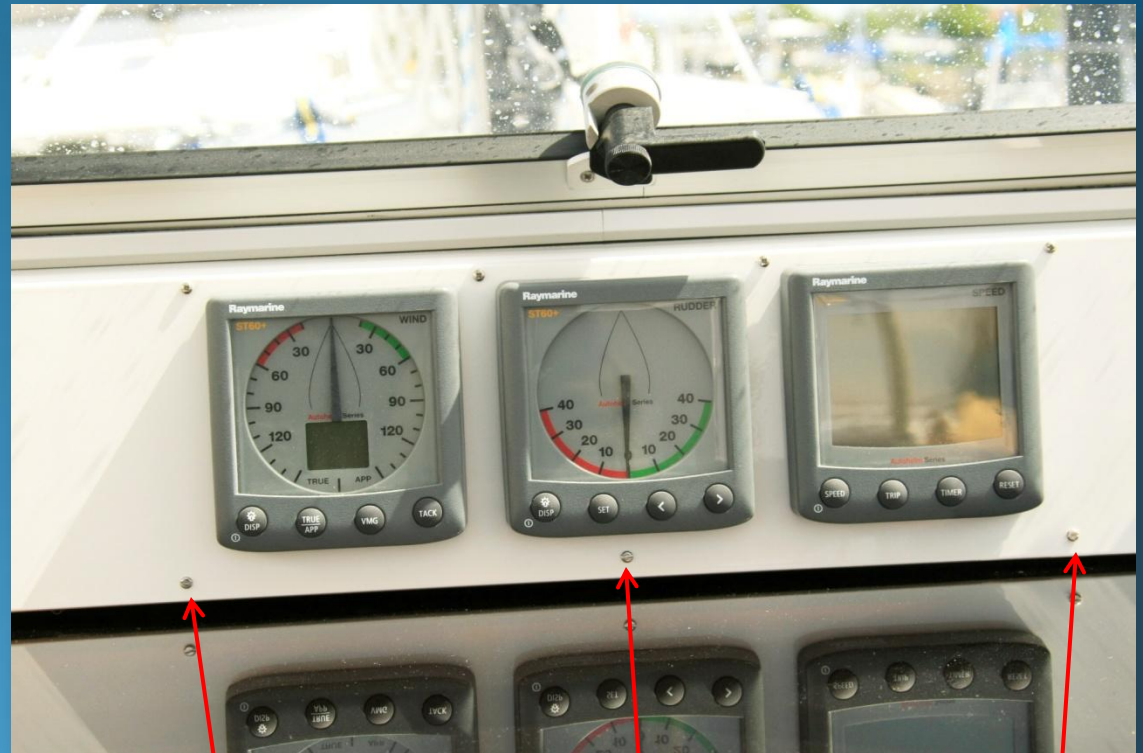
# Instrumentpanel och RedKnows sensor

Sensor to the alarms that was attached on a silicon glued aluminum profile behind the dashboard. The profile fell down, after 3 days and risked to seriously scratch the hatch in plexi glass.

We urgently addressed the defect.
