# HR 37 "Mia Maria" in her preferred element

Delivered on  
13th May 2008

# Delaminated hull!?

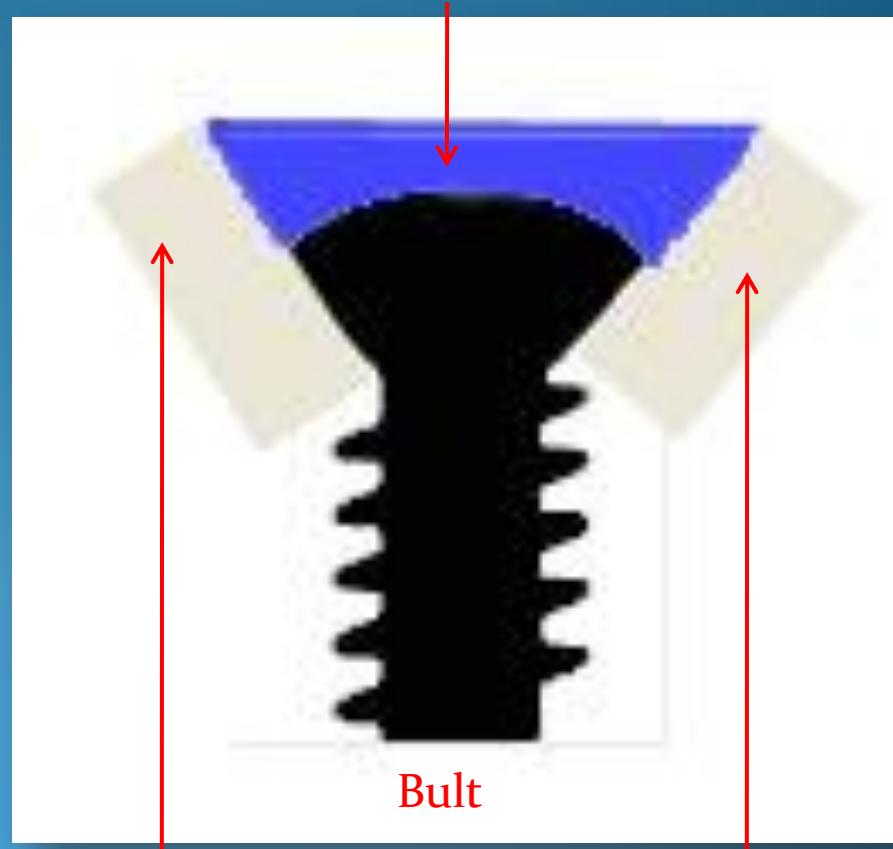
After sailing there were water droplets inside the skylight in the toilet. When the screw was removed it was found that no seal was applied to the screws.

The design means there is always a pool of water above the bolt head with corrosion between aluminum and stainless as a result.

Here are collected water

Aluminium frame fixed ondeck

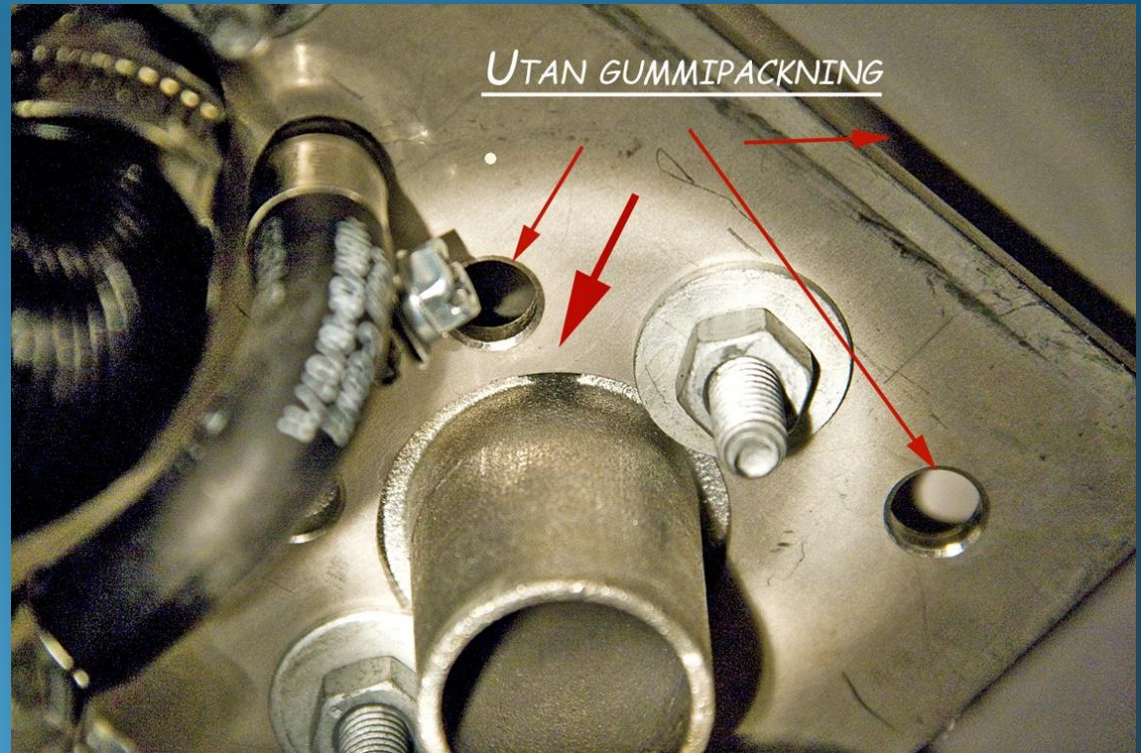
# Webasto heater - problem throughout 2008

Failed to start after work

HR indicated the error to the sensor on the wall and sent new to Karlskrona several weeks later for our own replacement. This was not the error.

**The heater was replaced in Soedertaelje by KG Knutsson.  
No help from HR**

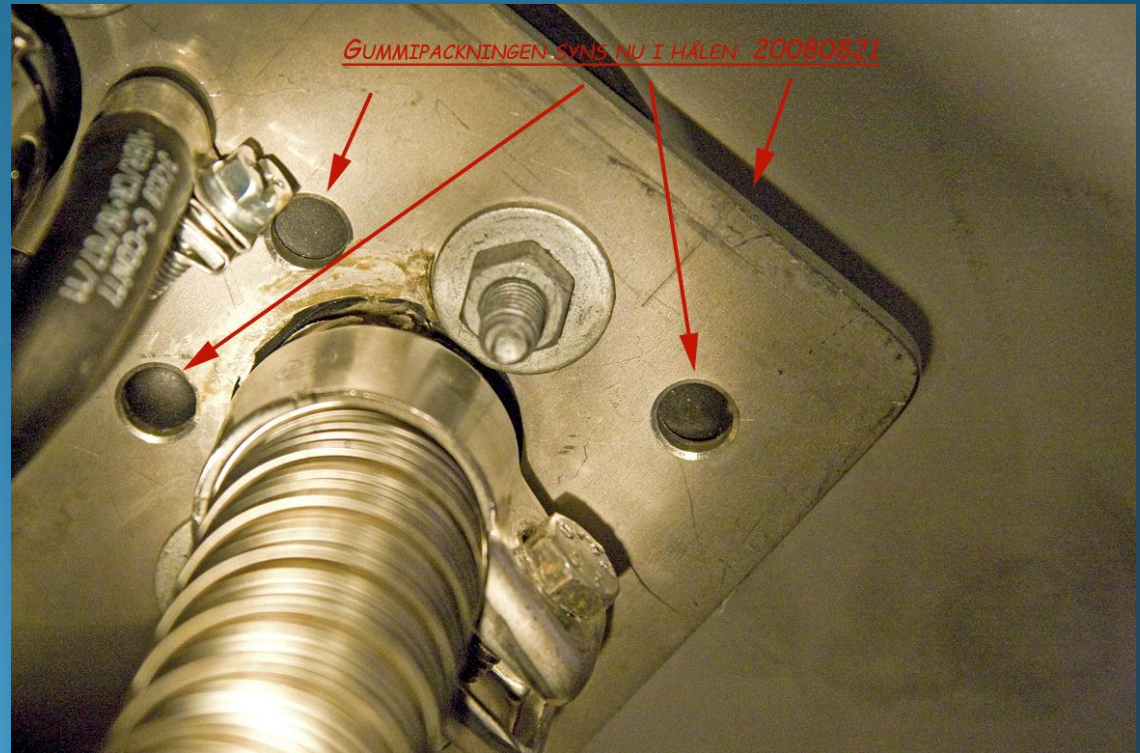
# Webasto heater - problem throughout 2008

The heater has to KG Knutsson and Bilelektro. The heater was removed a number of times before it was changed. Rubber gasket was missing. Leak in combustors spewing exhaust in the engine compartment, etc. Combustion chamber exchanged again.

First in season 2009 did the heater work well.

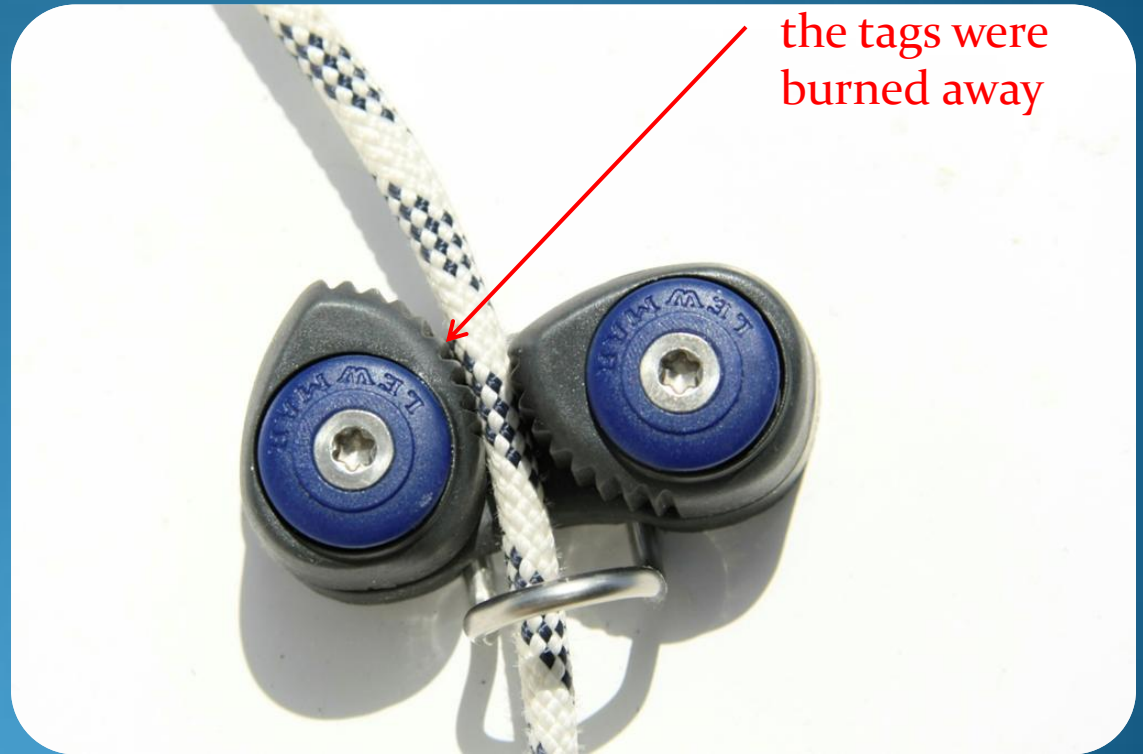
*All clamcleats and travelers did not work when sailing the new boat at home. Letter to HR 080614*

The jaws did not read the line, but the tags were burned away

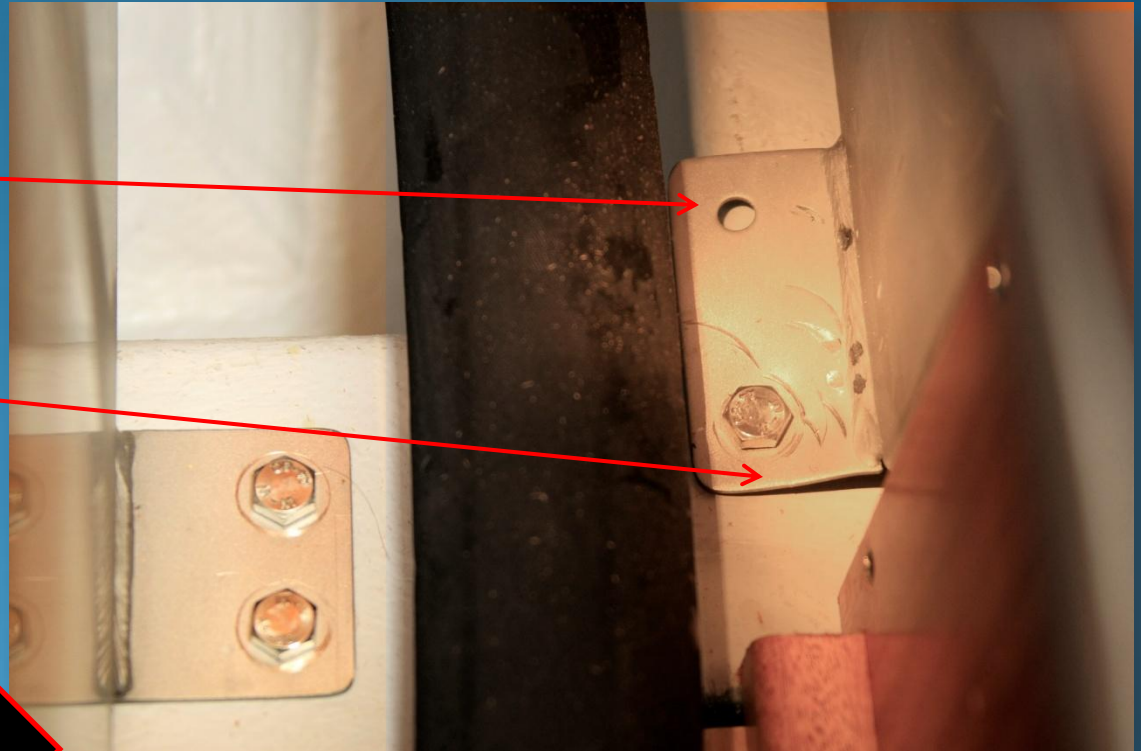
# Water tank was not bolted all over

HR only put adhesive in and pulled down with Bolt

Should be addressed to the ground.

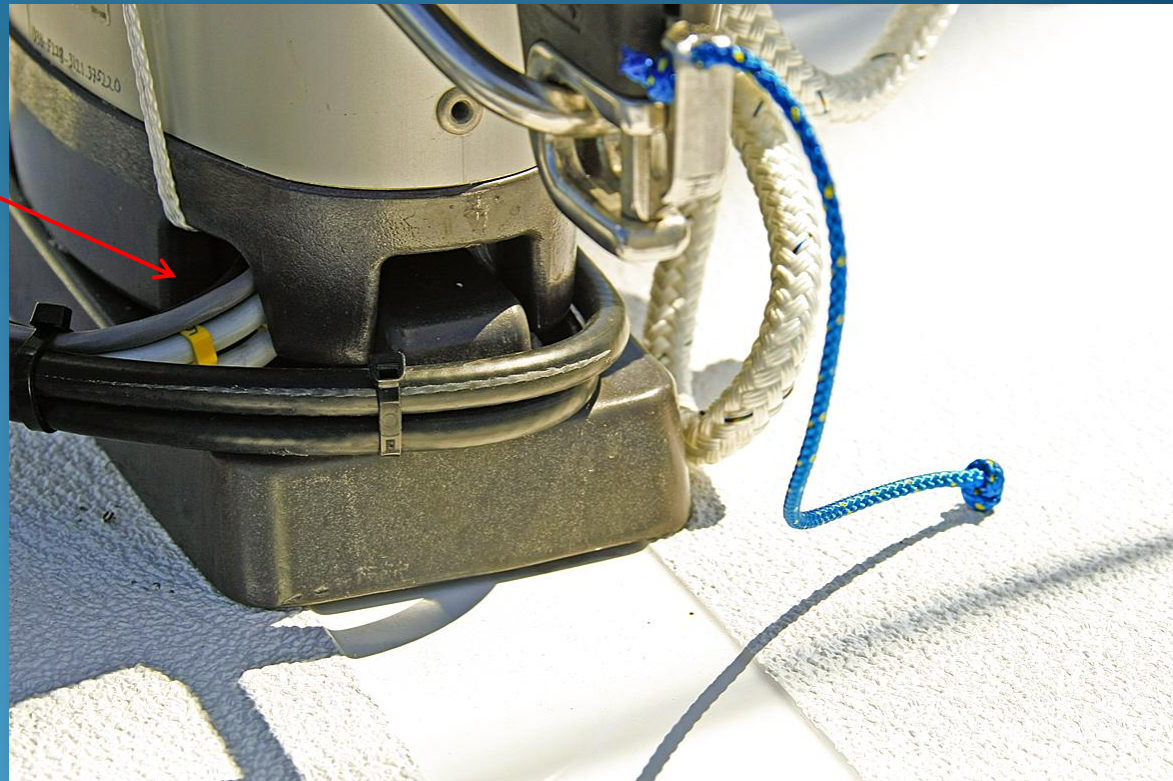
## Aluminium disc. Halyards and endless line

Sawn disc for a cable exit to radar  
This diec was among the cables  
and damaged the cable sheathing.  
Halyards and the endless line:

Had to go by engine to  
Gothenburg. After a few idle days  
Seldénmast changed this after  
checking .
